Groyne Deterioration

The tropical greenheart timber groynes were installed over twenty years ago.

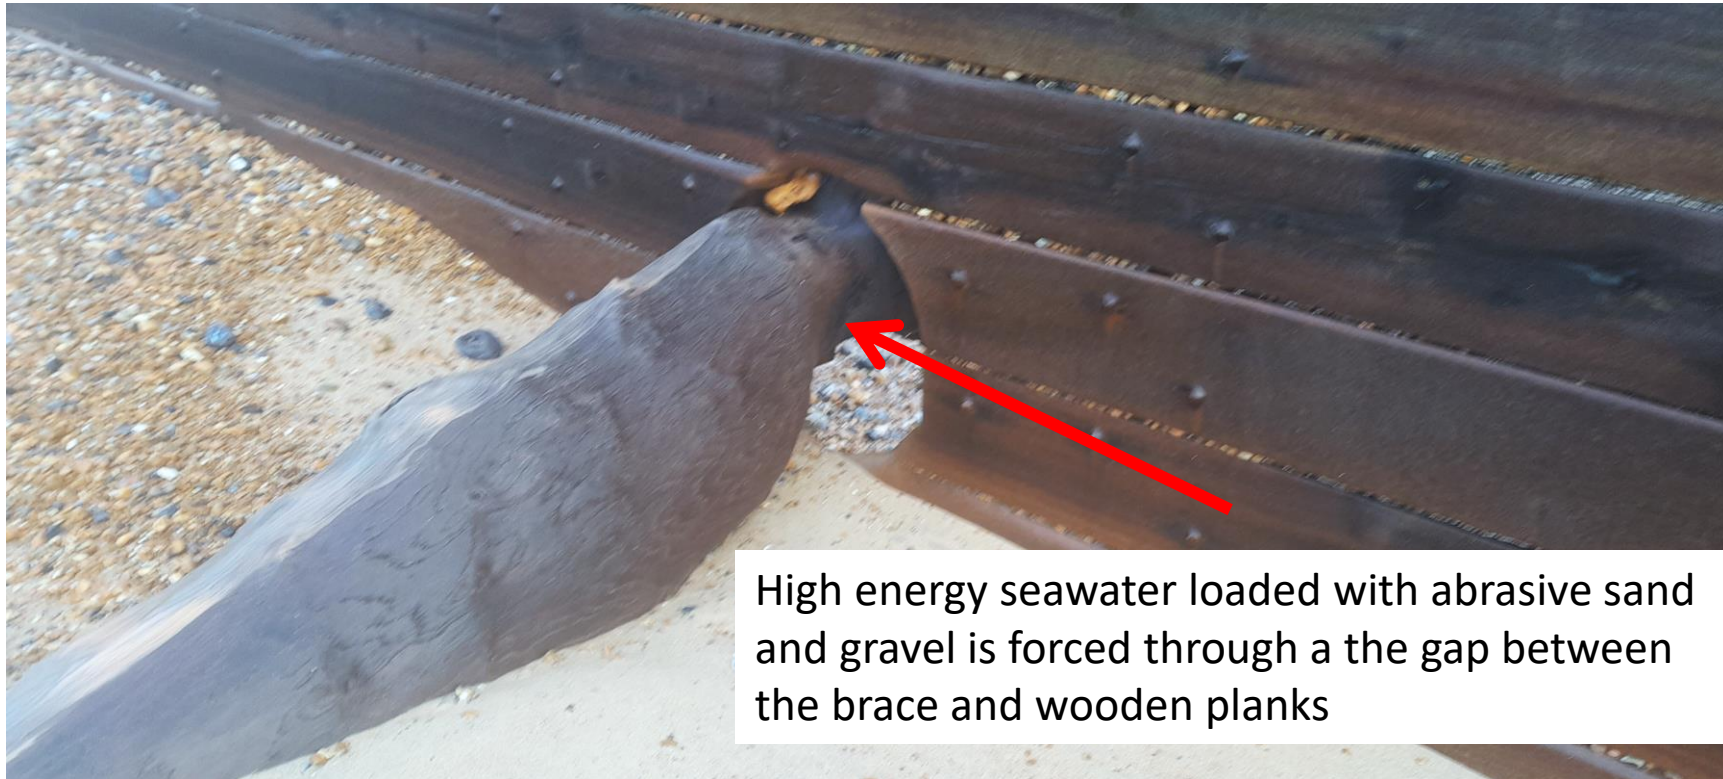
The hardwood groyne is partially supported by braces over one meter in circumference.

Sand and gravel assimilated within the breaking waves and back-wash have effectively sanded away more than 50% of the brace in the two decades since construction.

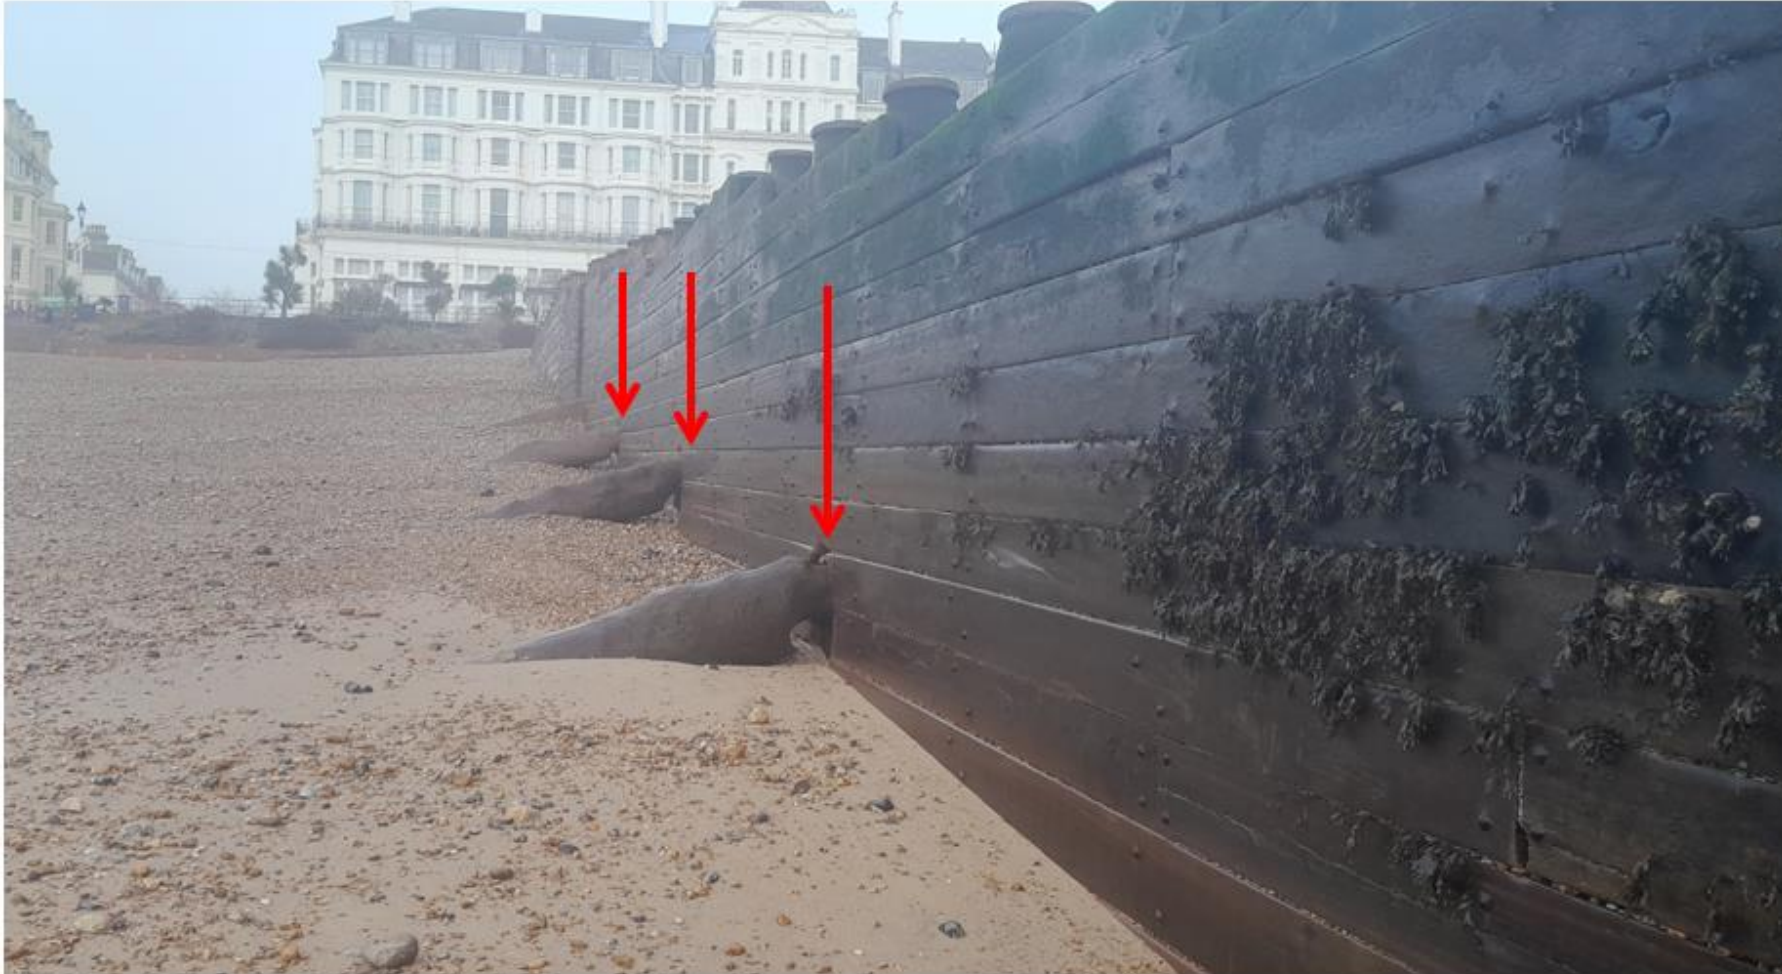
High energy seawater loaded with abrasive sand and gravel is forced through a the gap between the brace and wooden planks

The three affected braces are situated along a section of the beach where the slopes induce surging waves, that are loaded with abrasive sediments. As the gaps become larger the erosion accelerates. This problem is due to two factors; exposure and high content of abrasive fines within the beach sediments. The problem is not encountered on the beaches which are stabilised with cobbles.

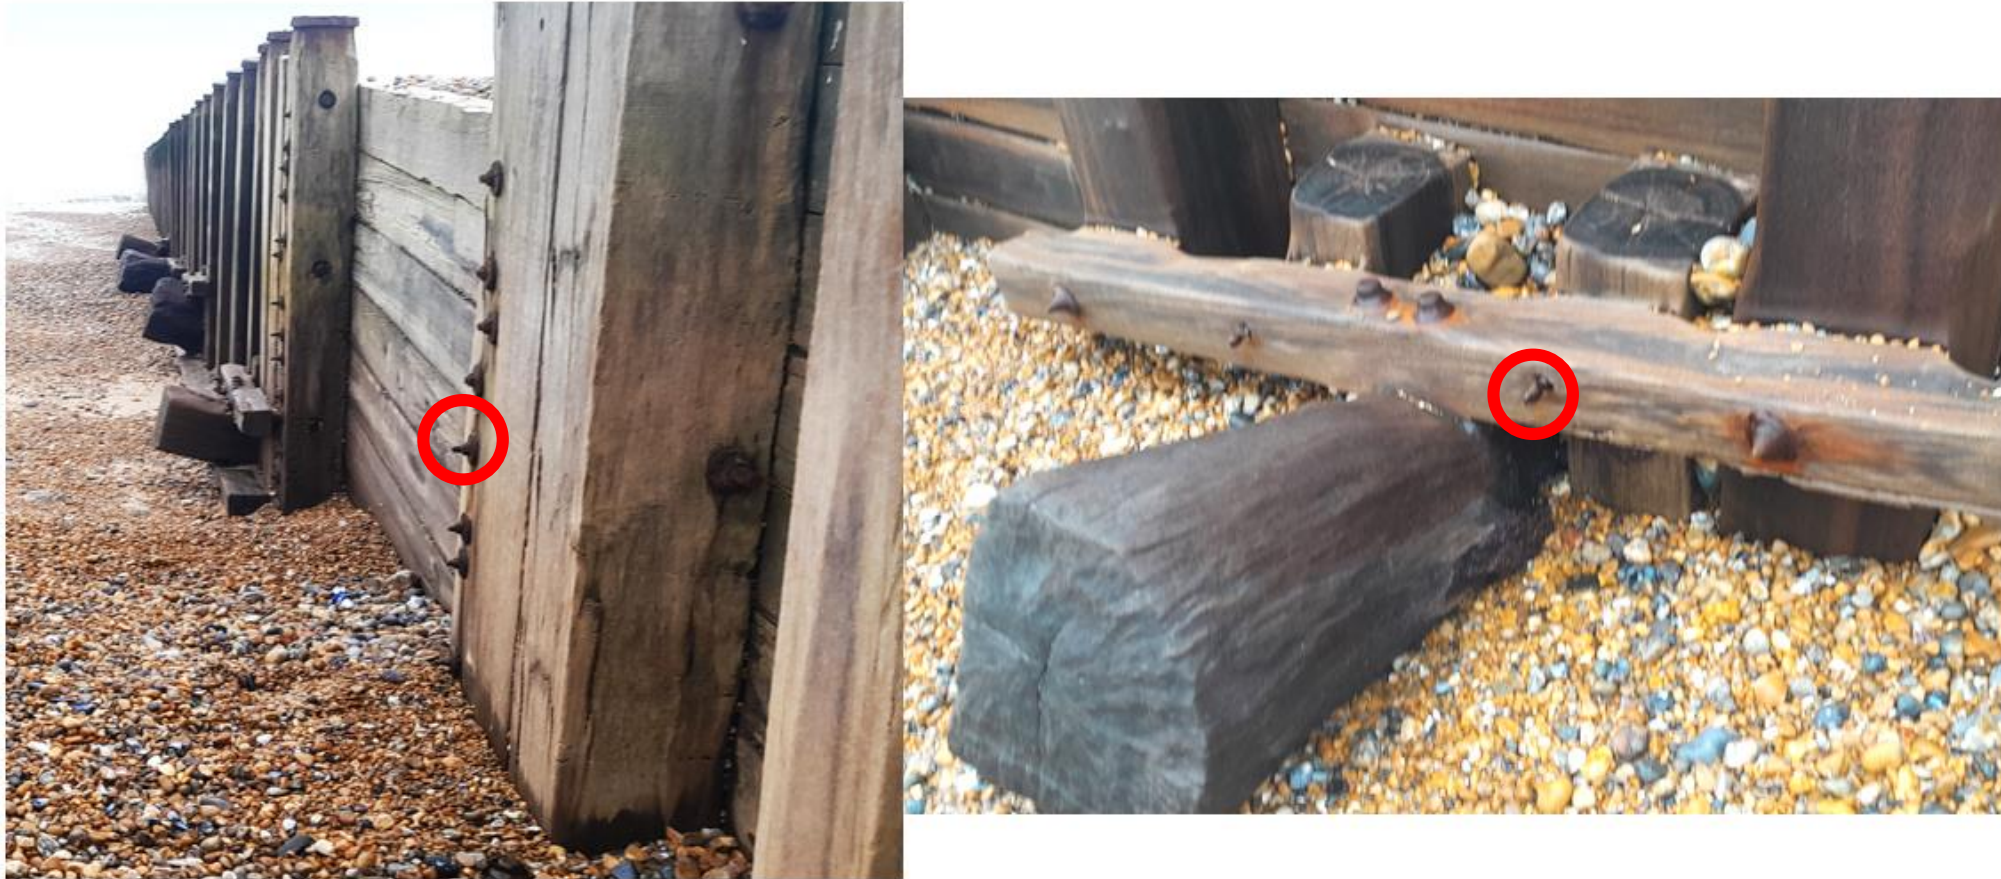
The nuts and most of the washers have been worn away by the action of water-borne flint clasts and sand . In time these wooden elements will become separated.

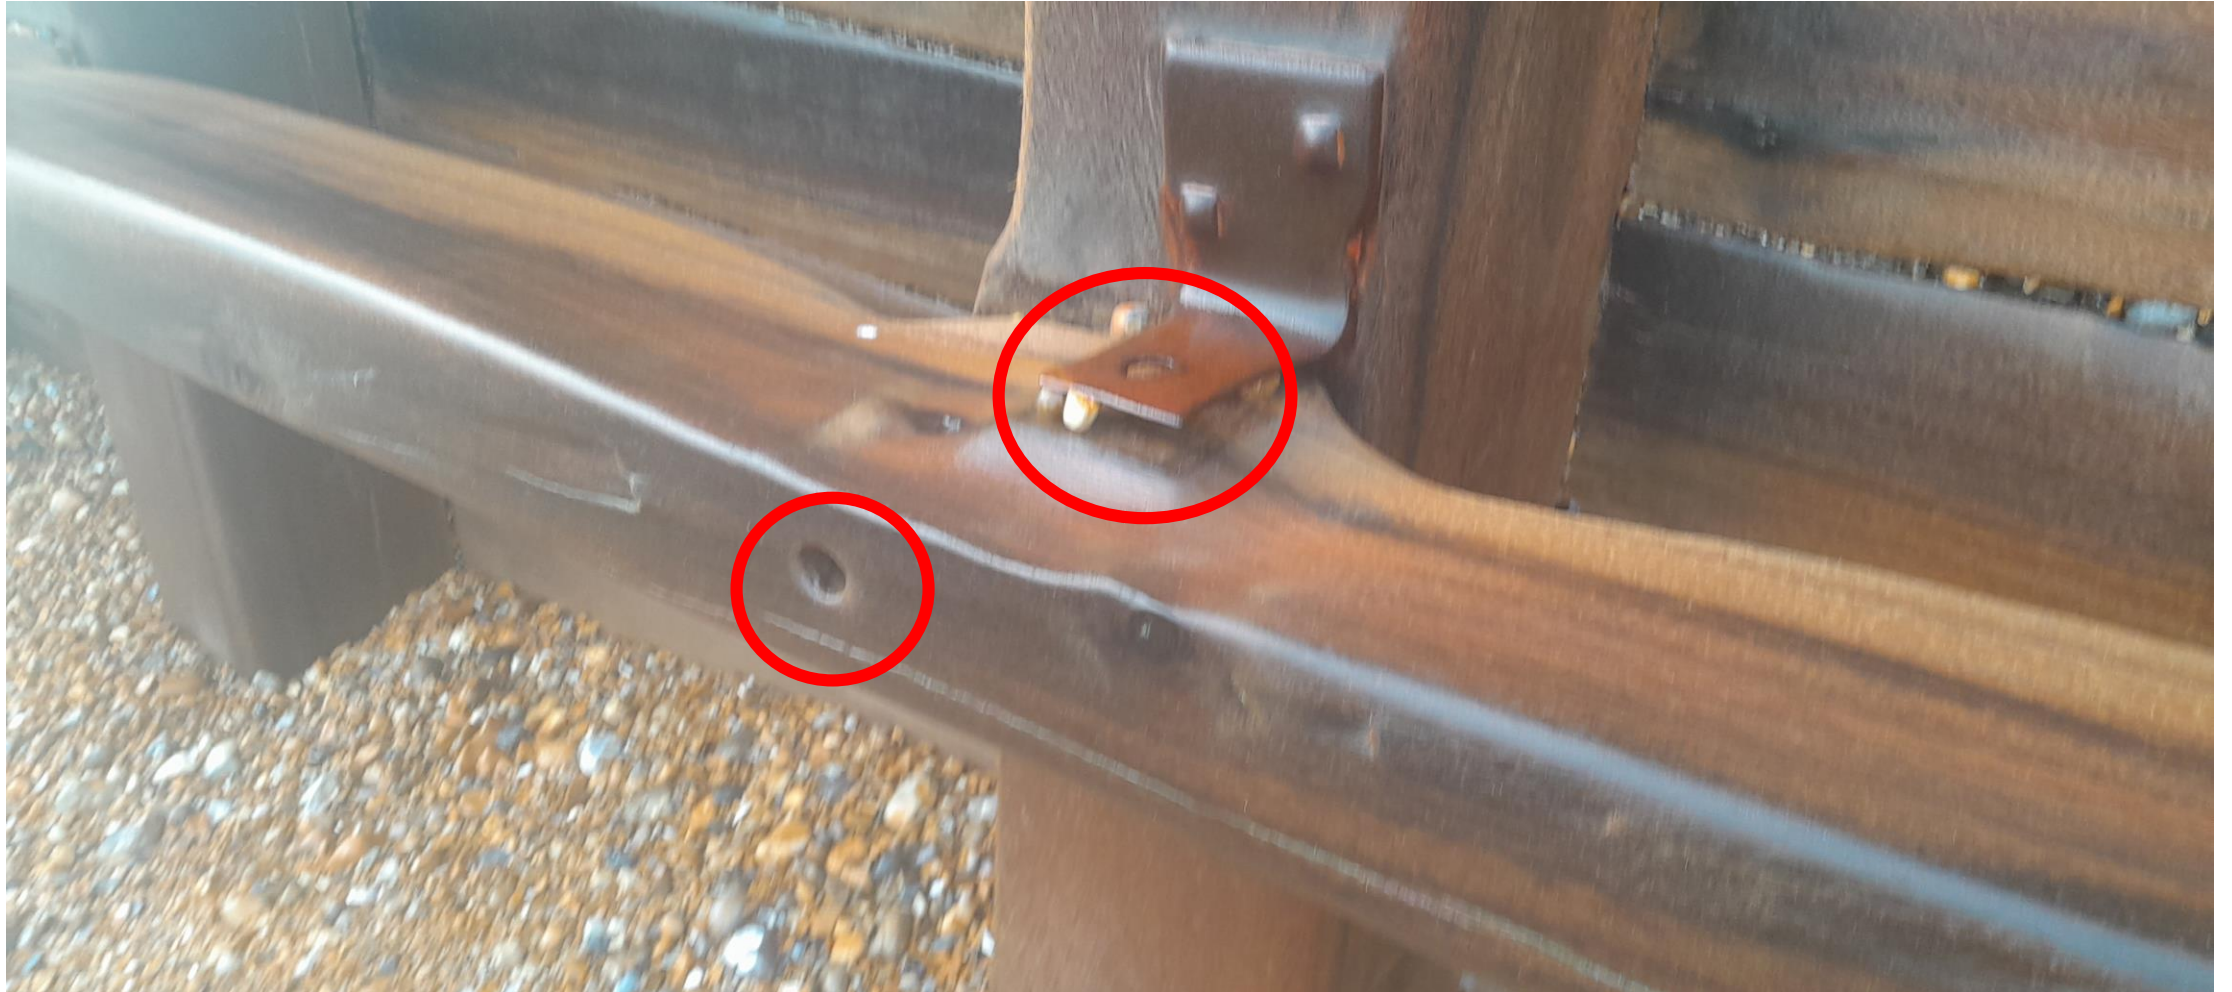
The same abrasive force has also worn off the nuts securing the trough bolts that secure the wooden elements.

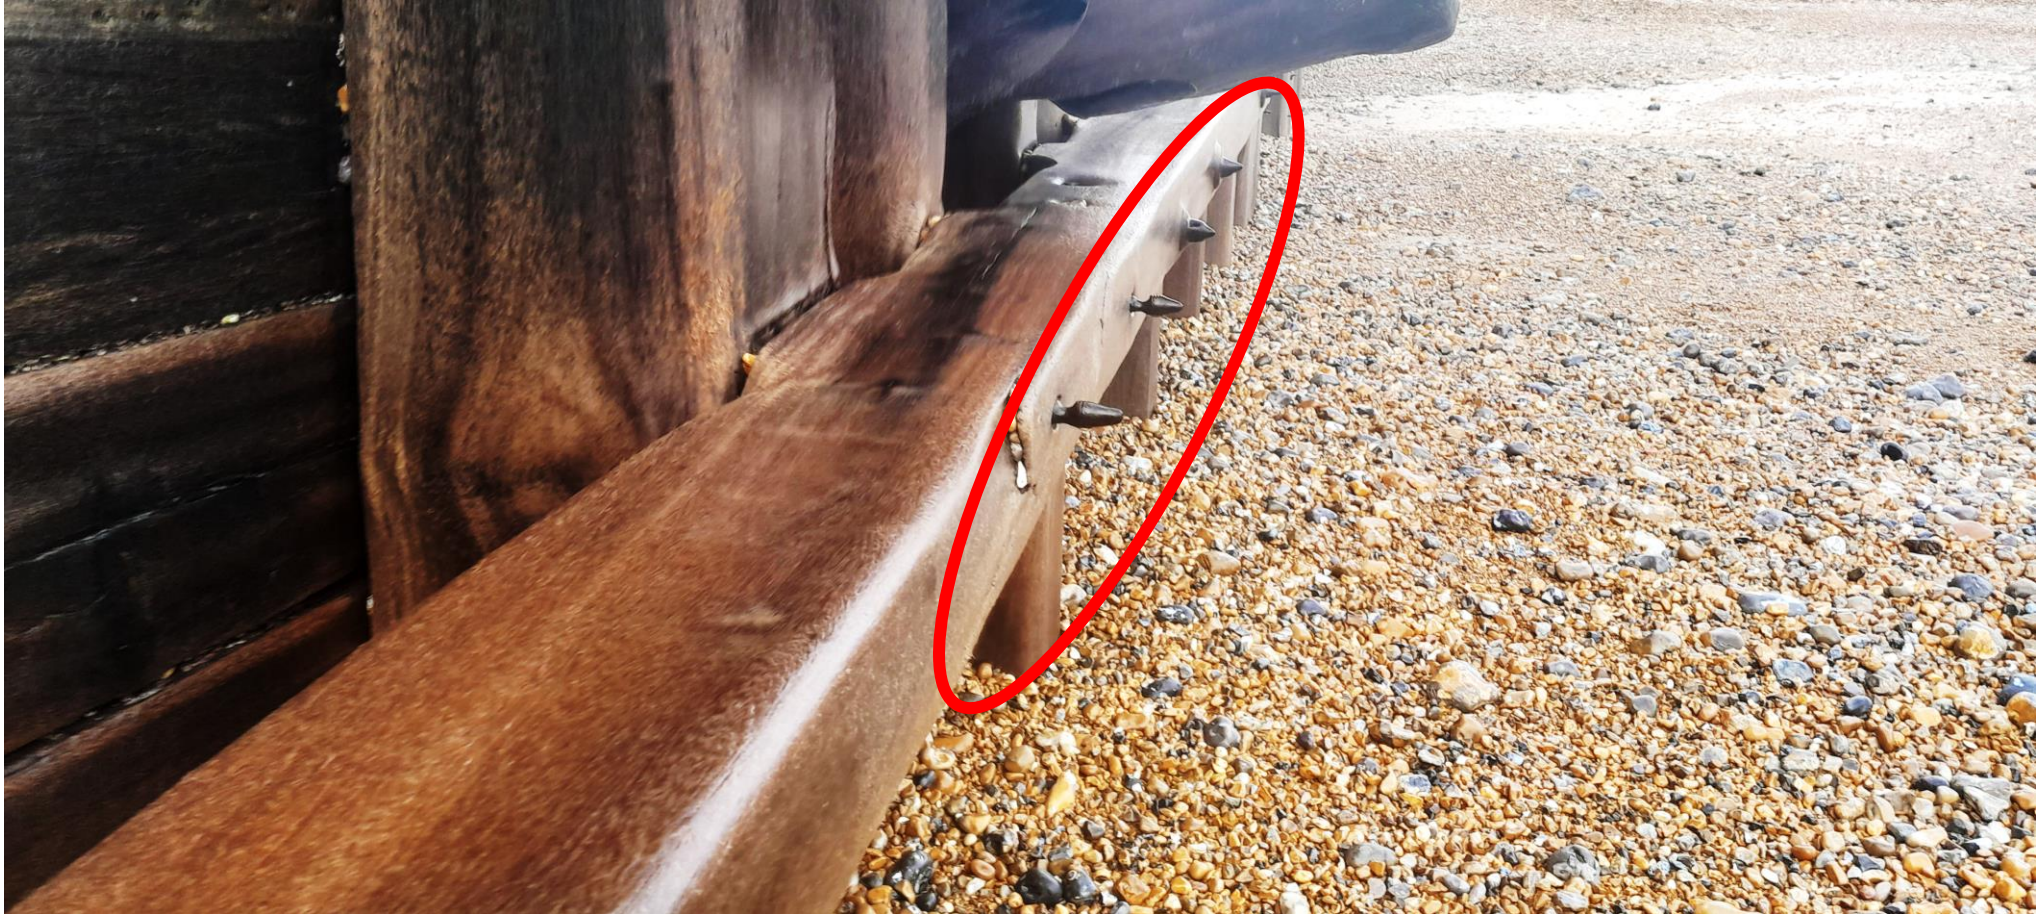
Through bolts are no longer secured with nuts.

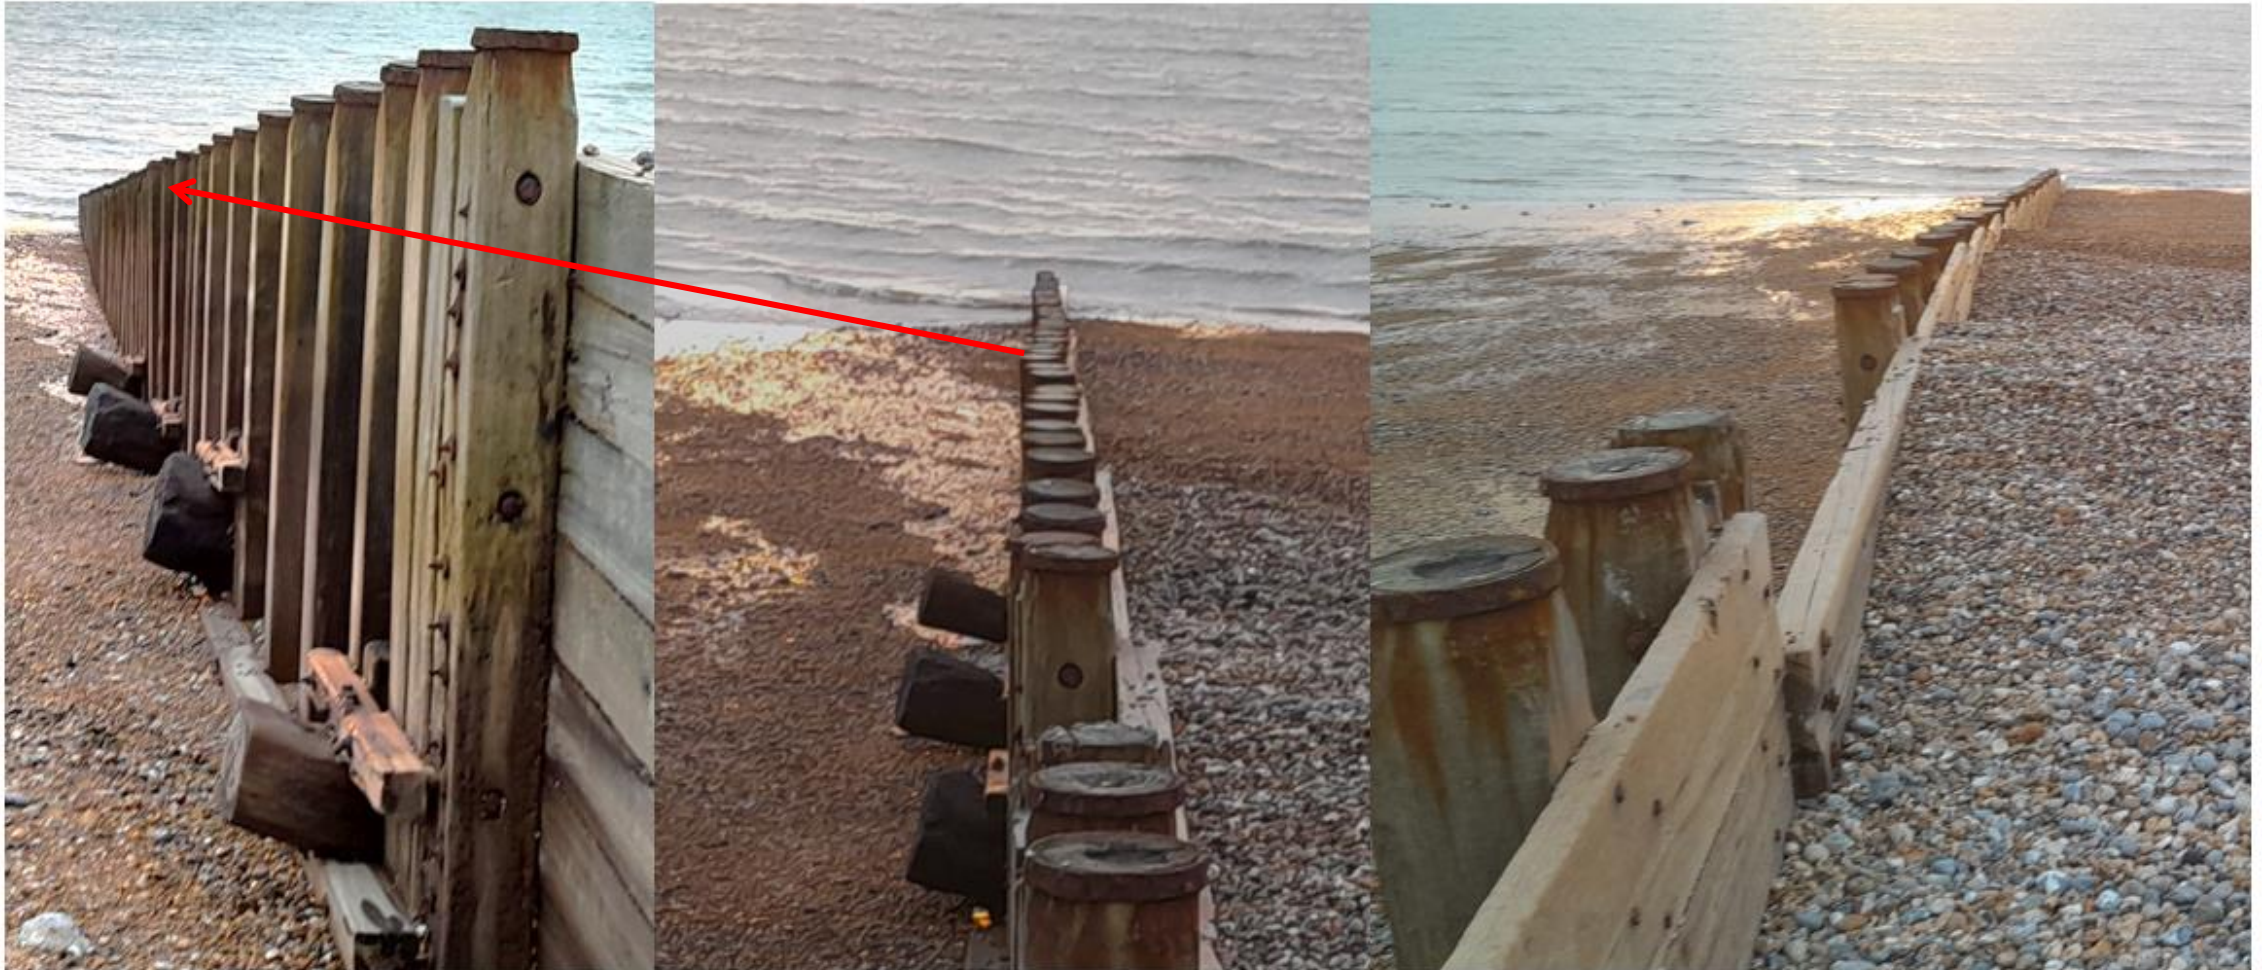
The drifted ballast moves from west to east, loading the western side of the groyne structure, resulting in significant loading along the western face of the groyne, which has moved some elements a noticeable distance. In some cases there is more than a 3 meter drop.

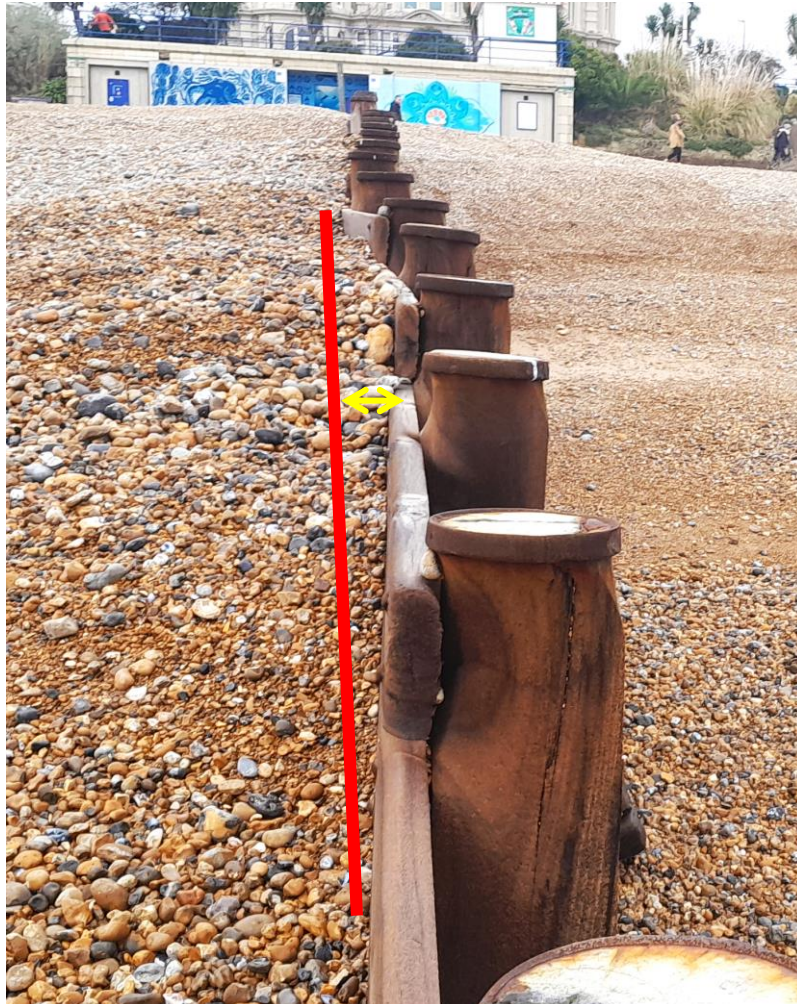
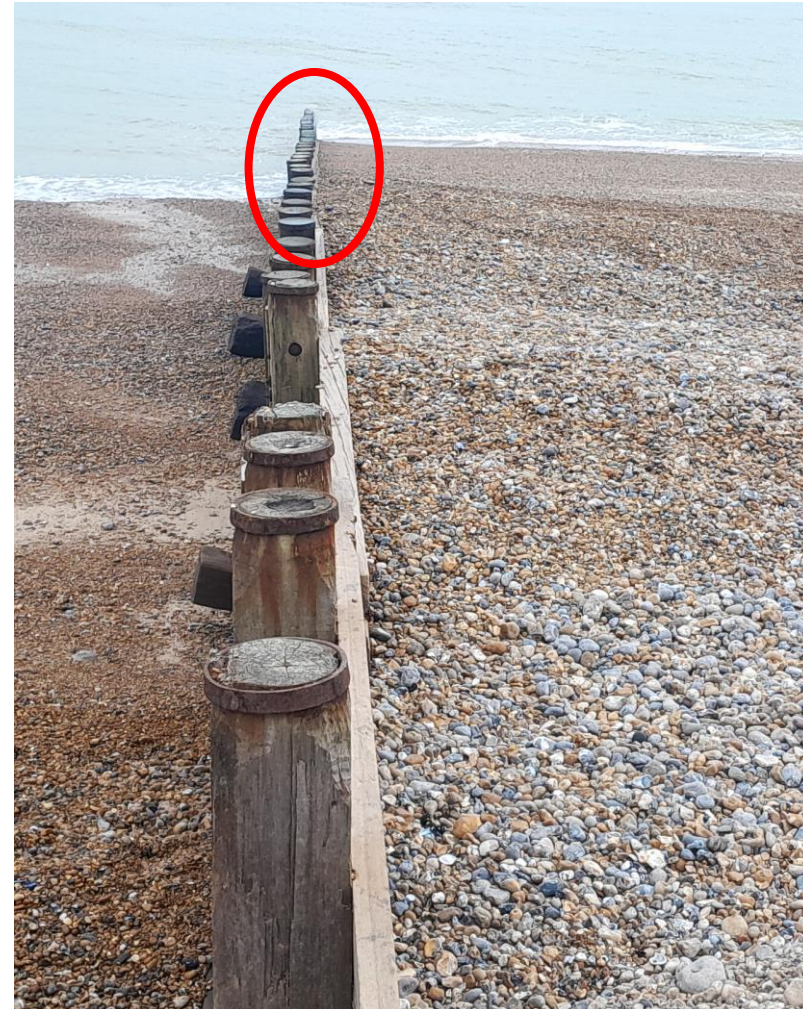
After installation the vertical posts were aligned. Degradation of the iron fastenings combined with sediment loading on the western face has displaced the posts and adjoining planks towards the east. The ballast is washed to the opposite side of the beach during a run of easterly winds, releasing the loading. Gaps between the elements will appear and stones forced into these, further reducing the integrity of the groyne. This process may be repeated several times over the course of a year further weakening the structure.

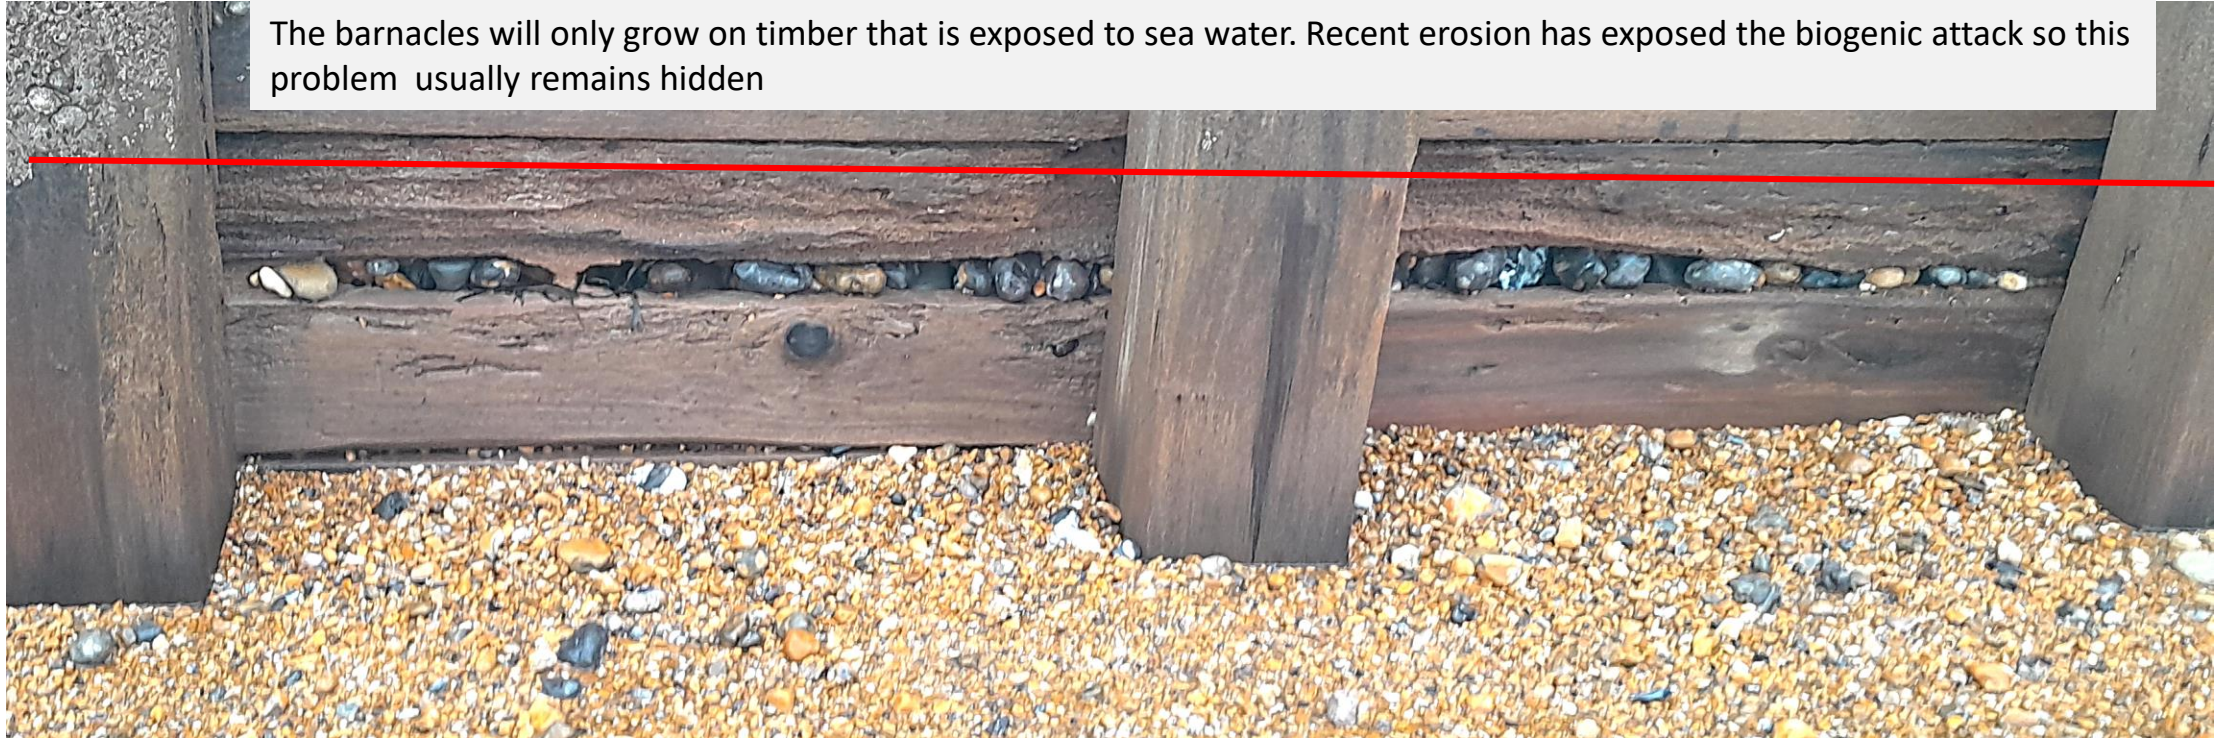
The barnacles will only grow on timber that is exposed to sea water. Recent erosion has exposed the biogenic attack so this problem usually remains hidden

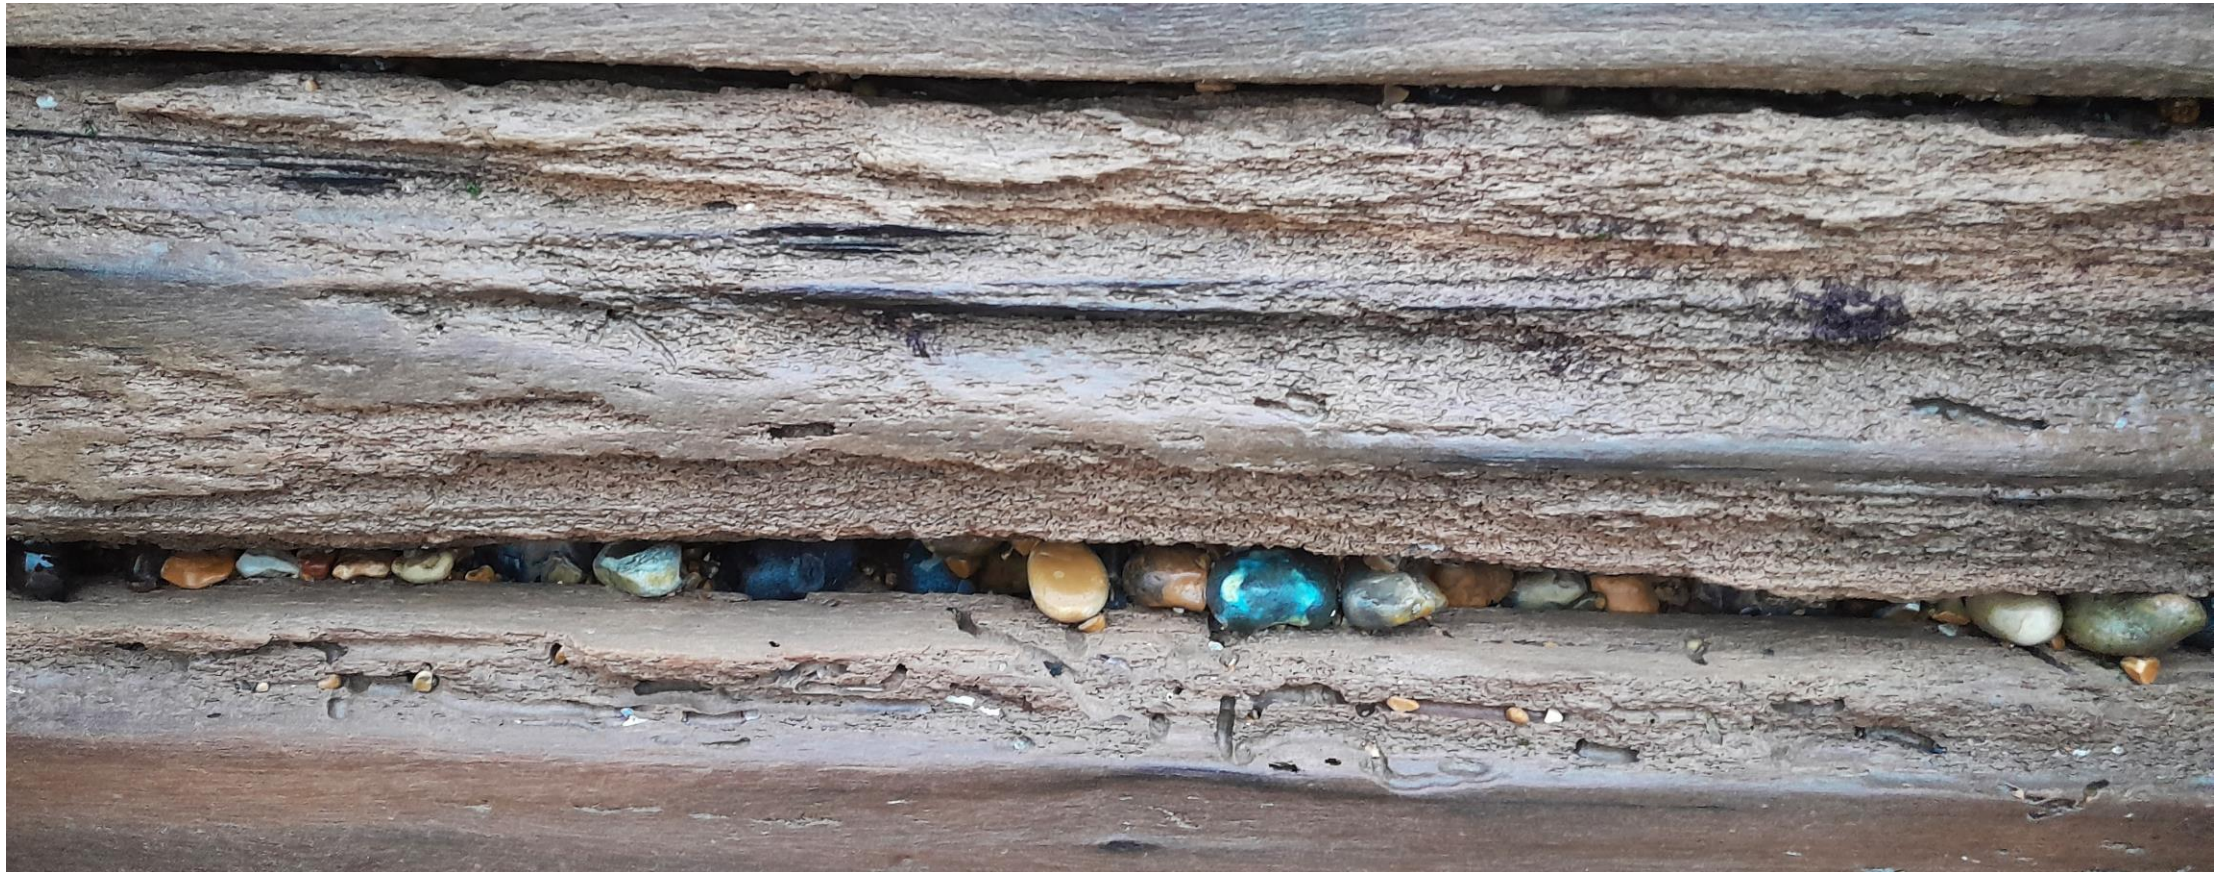
The wooden planks affected have recently been exposed and illustrating that degradation occurred whilst buried. A species of wood boring organism has eaten into the tropical hardwood. There are a variety of native marine wood boring organisms and recently invasive species have been reported within UK waters. The red line indicates the level of sand prior to the storms that caused the erosion.

The deterioration is confined to the buried section reducing the resistance to the loading described above. The exposed timber is relatively soft and will therefore, be worn away at a faster rate than the unaffected timber sections.
