SeaScapes 2030

Beach Erosion Case Study

Short, Medium, and Long Term
Beach Erosion Analysis

Beach Survey at Eastbourne Bandstand

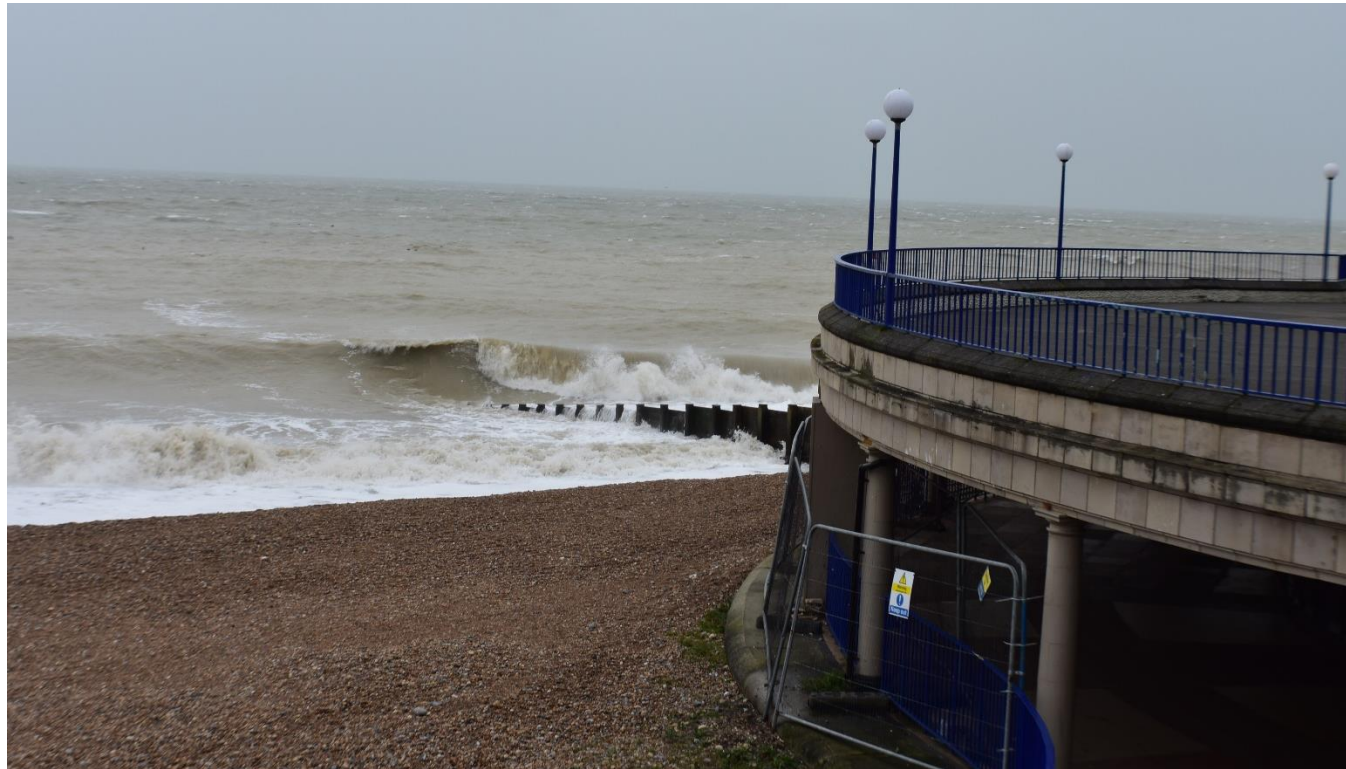
The survey was conducted as storm Dudley was building, the resultant waves impacted onto the beach at an approximate angle of 45° (Figure 1). This is the prevailing direction and demonstrates the forces responsible for moving the shingle north-eastwards.

Figure 1: Photograph of the beach fronting Eastbourne Bandstand. Taken on 18th February 2022 as storm Dudley was building during the ebbtide. Waves from a southwest direction impacting on the beach at approximately 45° . Photo G. Caira.

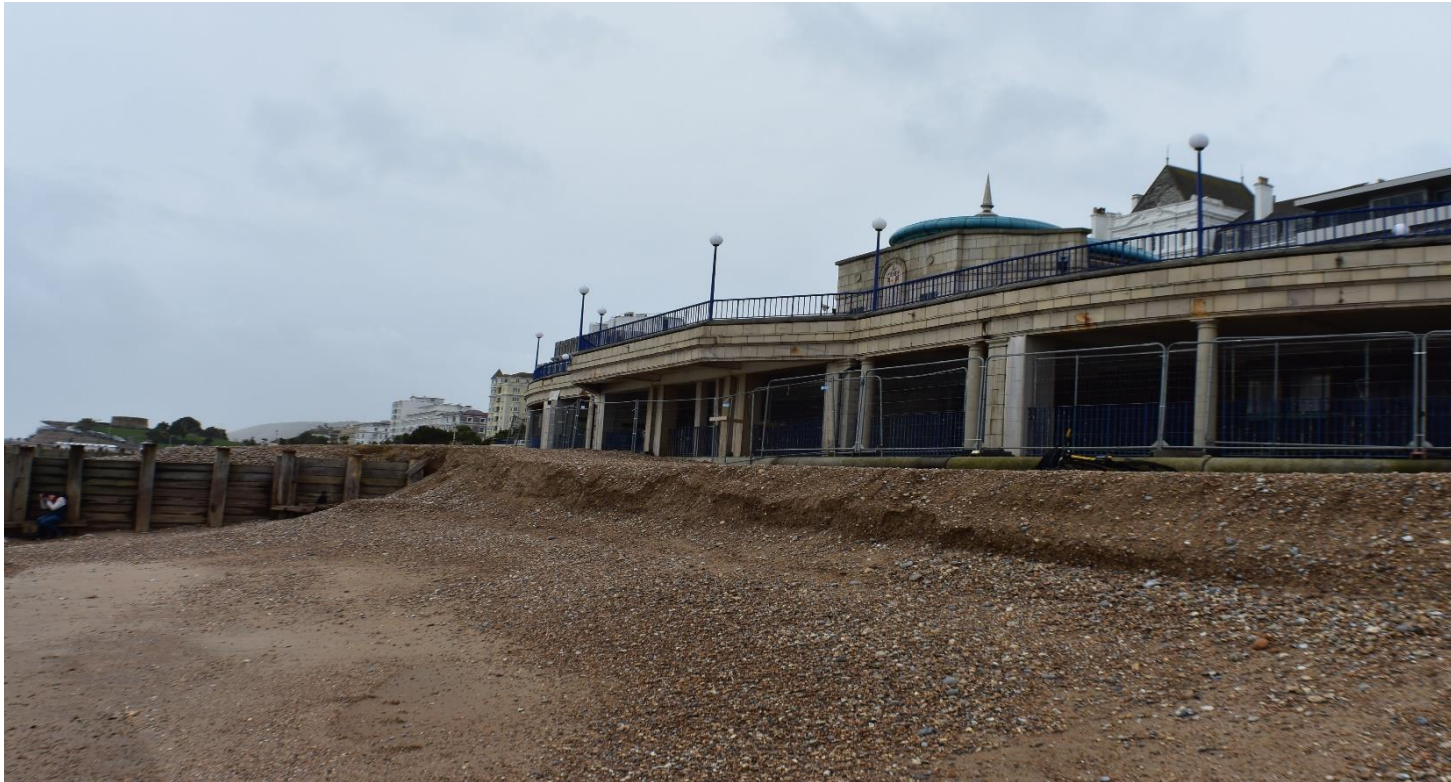
Figure 2: *The beach after storm Dudley and initial impact of storm waves. There is a significant sand content in the beach deposit mixed with small round pebbles that has very likely contributed to the apparent acceleration in erosion since 2018. Photo G. Caira.*

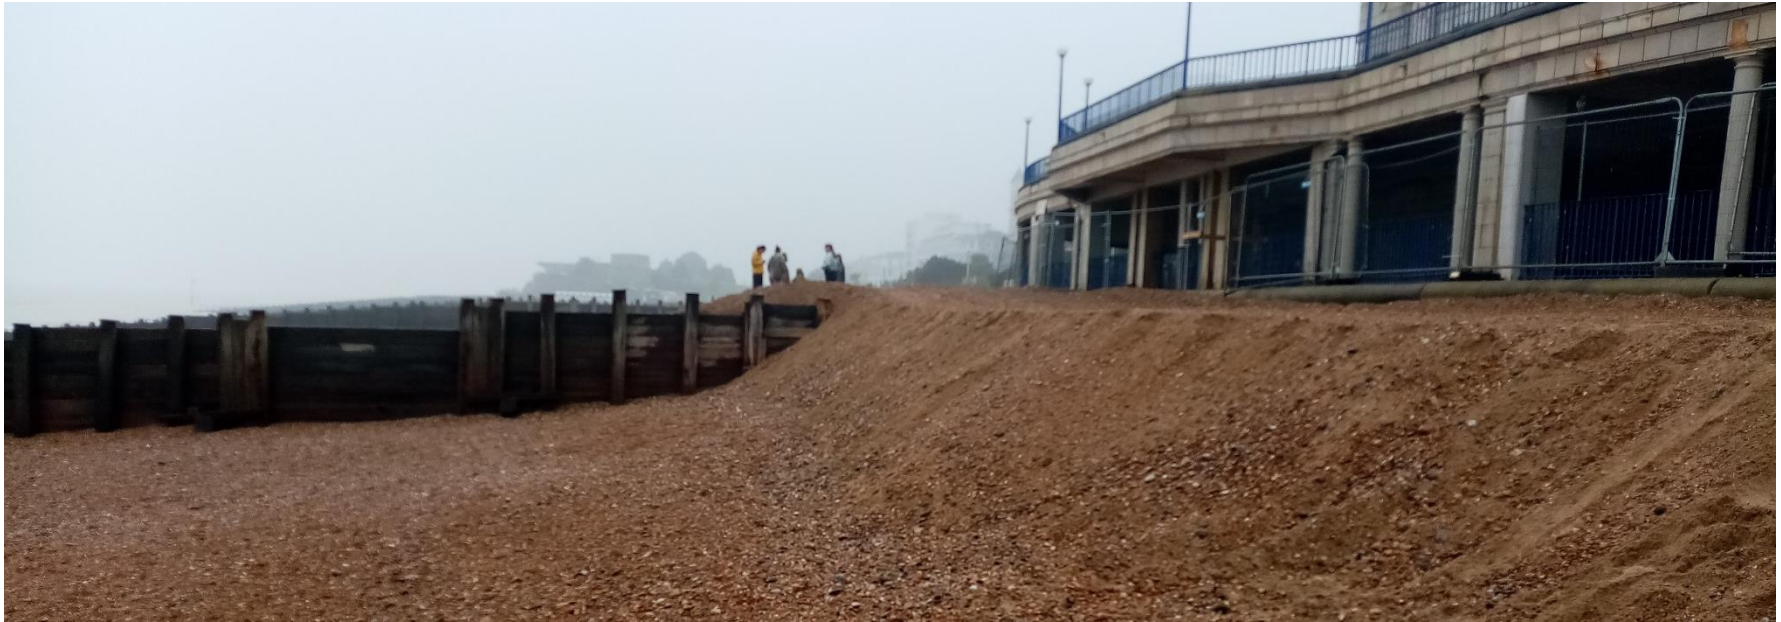
Figure 4: *The Bandstand beach after reprofiling work undertaken on 1st March 2022. Photo G. Caira. There appears to be more sand than shingle in the newly formed beach head. This mix of sand and shingle does not provide much protection and is easily washed away by storm waves.*

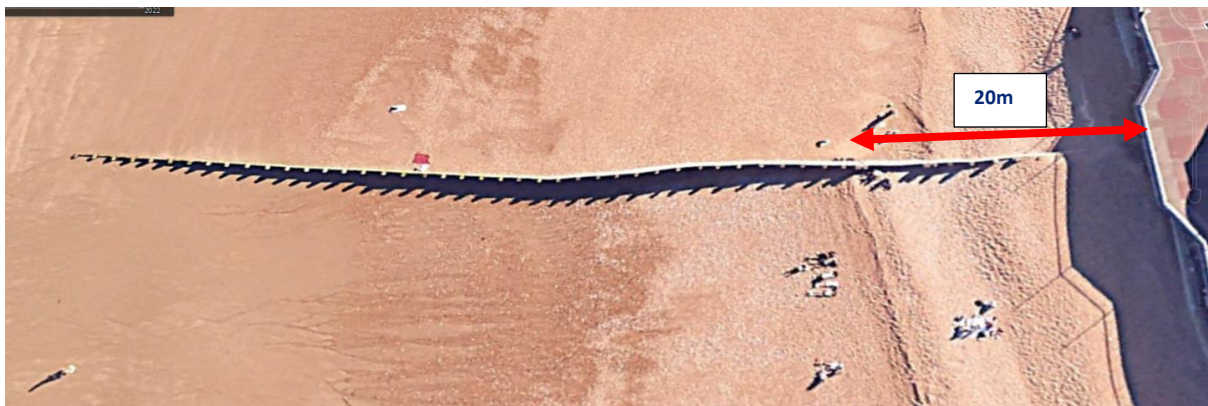
The image below is from May 2022 and the beach head is approximately 20 m further seaward.

Figure 1: Satellite Image showing beach head HW to be within 20 m of the bandstand in May 2022.

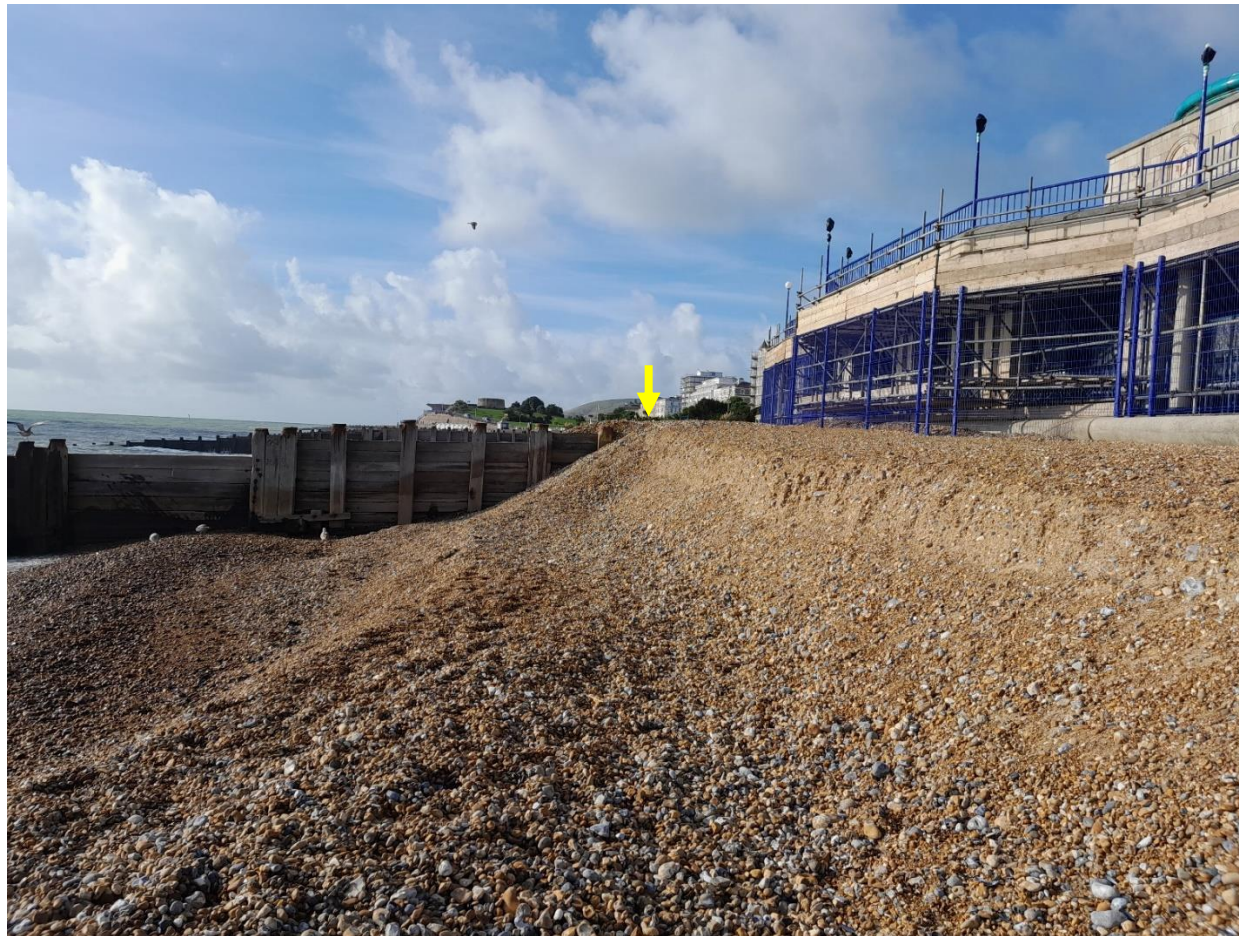
Figure 2: The Bandstand beach on 22nd Oct 2022. The beach has been recharged following the February storms and then eroded back around 17m during the summer and autumn. Photo G. Cairra.

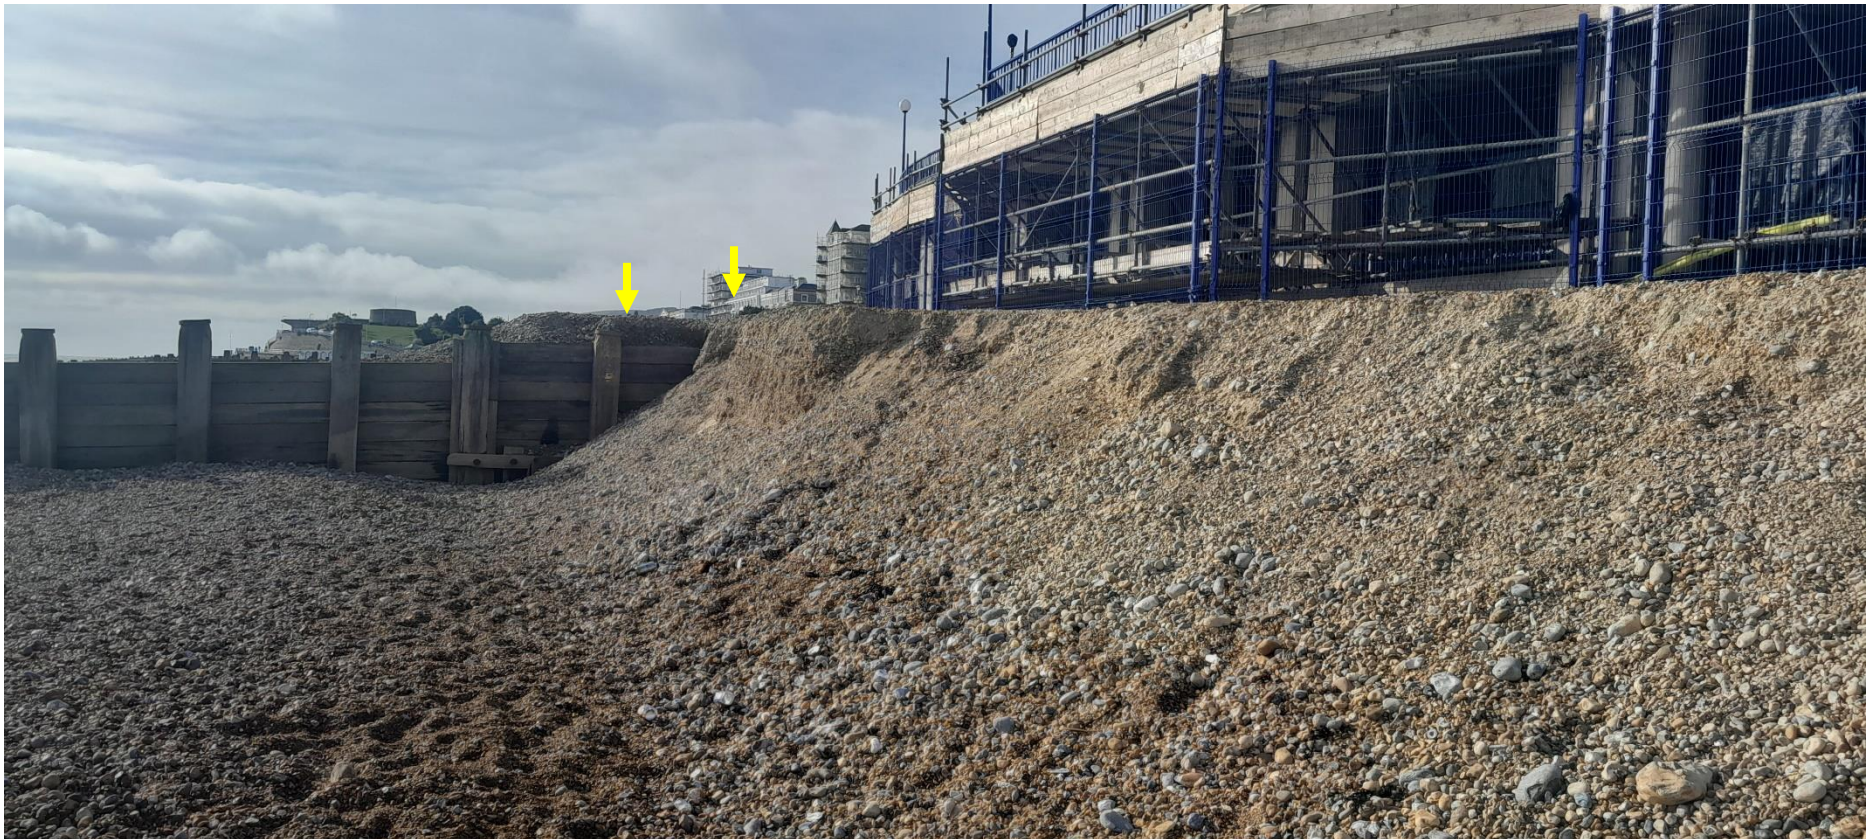
Figure 3: The Bandstand beach on 2nd March 2023. The yellow arrows indicate the distance the shingle sand mix has eroded back another 1.5 m over the winter. Photo G. Cairn.

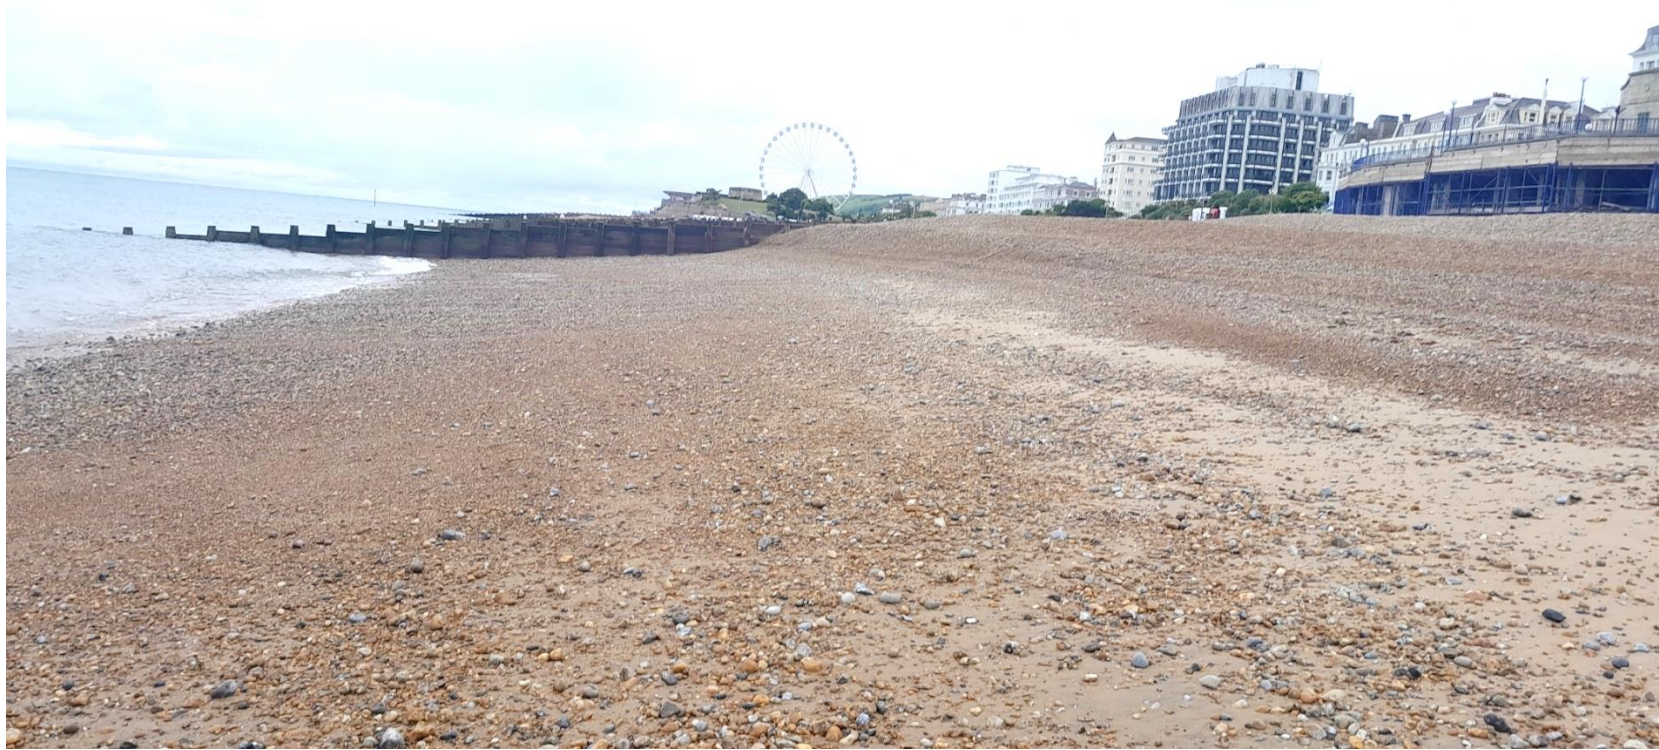
Figure 4: *The Bandstand beach on 29th June 2023. Using the beach loss model from the survey conducted in February 2022, the beach has been recharged with around 1000 m³ of unsuitable ballast. Which at previous costs of £15 per m³ equates to another £16,500 on just one of many beaches. Photo G. Cairn.*

Reprofiling with heavy machines has compacted the ballast into a hard slope that allows the clasts to easily roll down. Along the water's edge deposits of the grey cobbles have accumulated. Further up the beach the small round pebbles and sand have been easily washed into small ridges by the relatively calm sea.

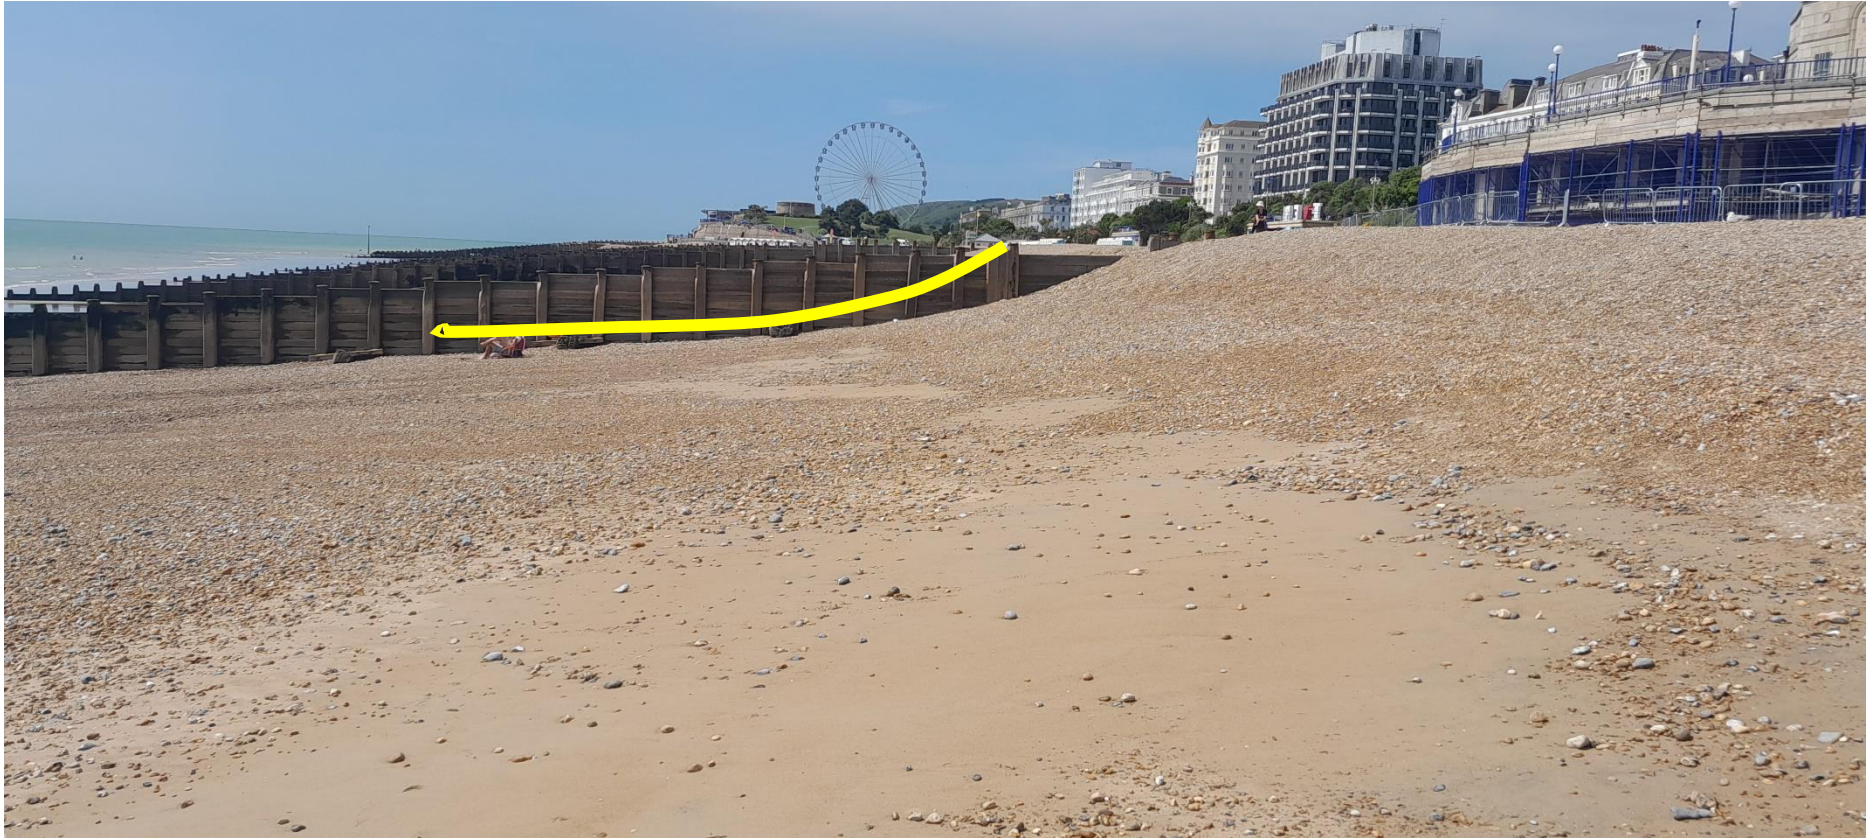
Figure 5: Bandstand beach on 10th July following long Spring tides, between the 4th and 6th July, combined with 1m swell waves impacting from the south west. This relatively benign set of marime conditions has stripped back a significant amount of the newly recharged beach. Photo G. Caira.

In early July 2023, during particularly long spring tides in conjunction with a 1m SW swell the ballast was eroded back 2m, equating to 110m³ across the beach.

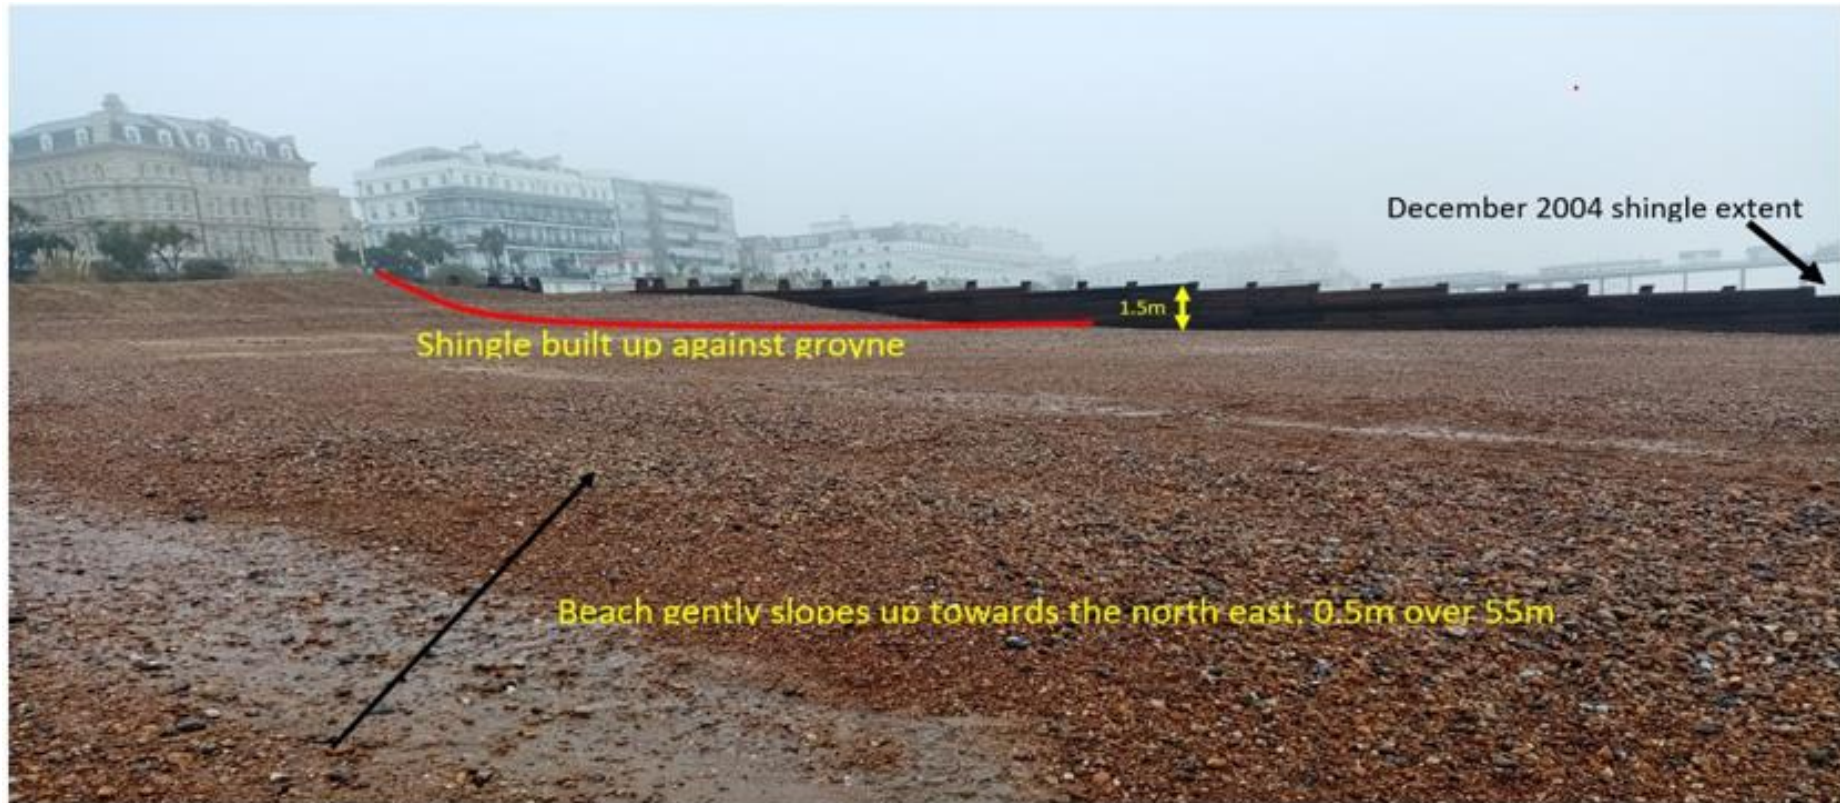
Figure 3: Northeastern side of the beach. The beach gently slopes up from the SW to NE laterally across the beach. The red lines follow the approximate trend of the deposit against the opposite groyne. Taken on 1st March 2022 after the three named storms had eroded and reprofiled the beach.
