## Case Study D Longshore Drift

### Mechanisms

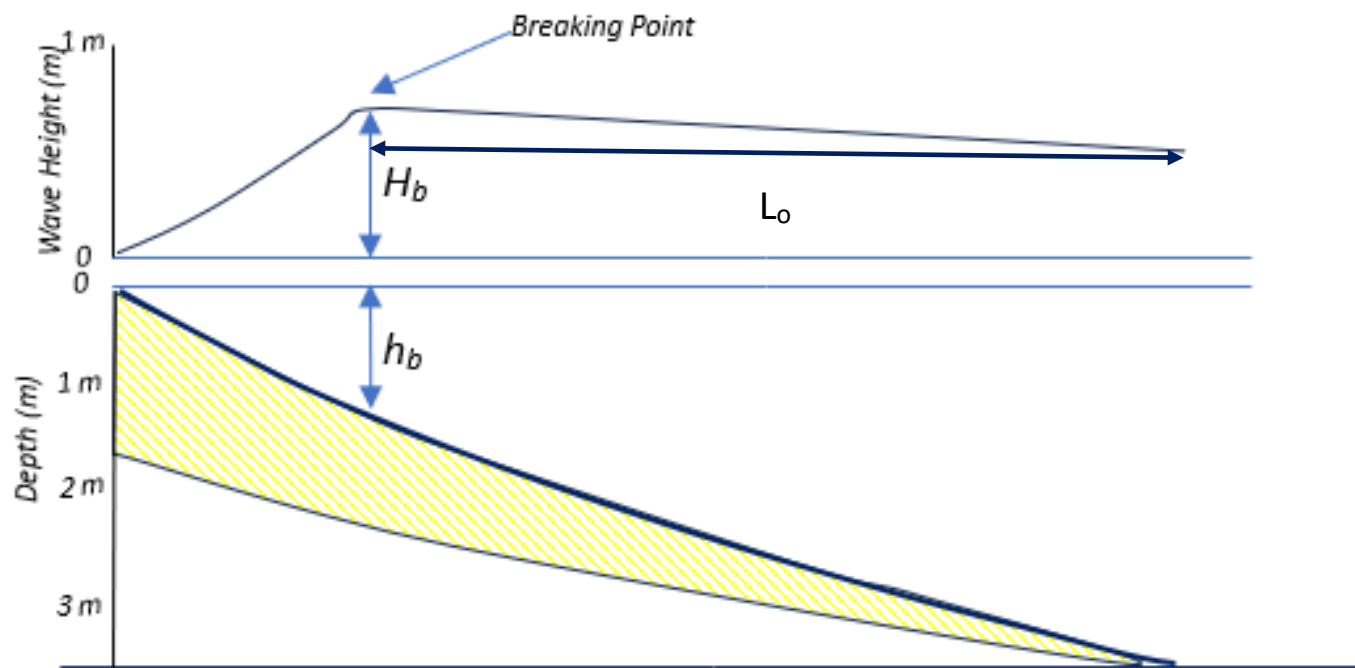
**Figure 3:** Relationship between water depth and wave height, the variables  $H_b$ ,  $h_b$  and  $L_o$

**Deep Water**

$h_b/L_o > 0.5$  waves unaffected by seabed

**Intermediate water and shallow water**

$h_b/L_o < 0.5$  waves affected by seabed

**Surf Zone**

$h_b < 1 H_o$  (regular waves) OR  $h_b < 2 H_o$  (irregular waves)

**Swash Zone**

$h_b = 0$

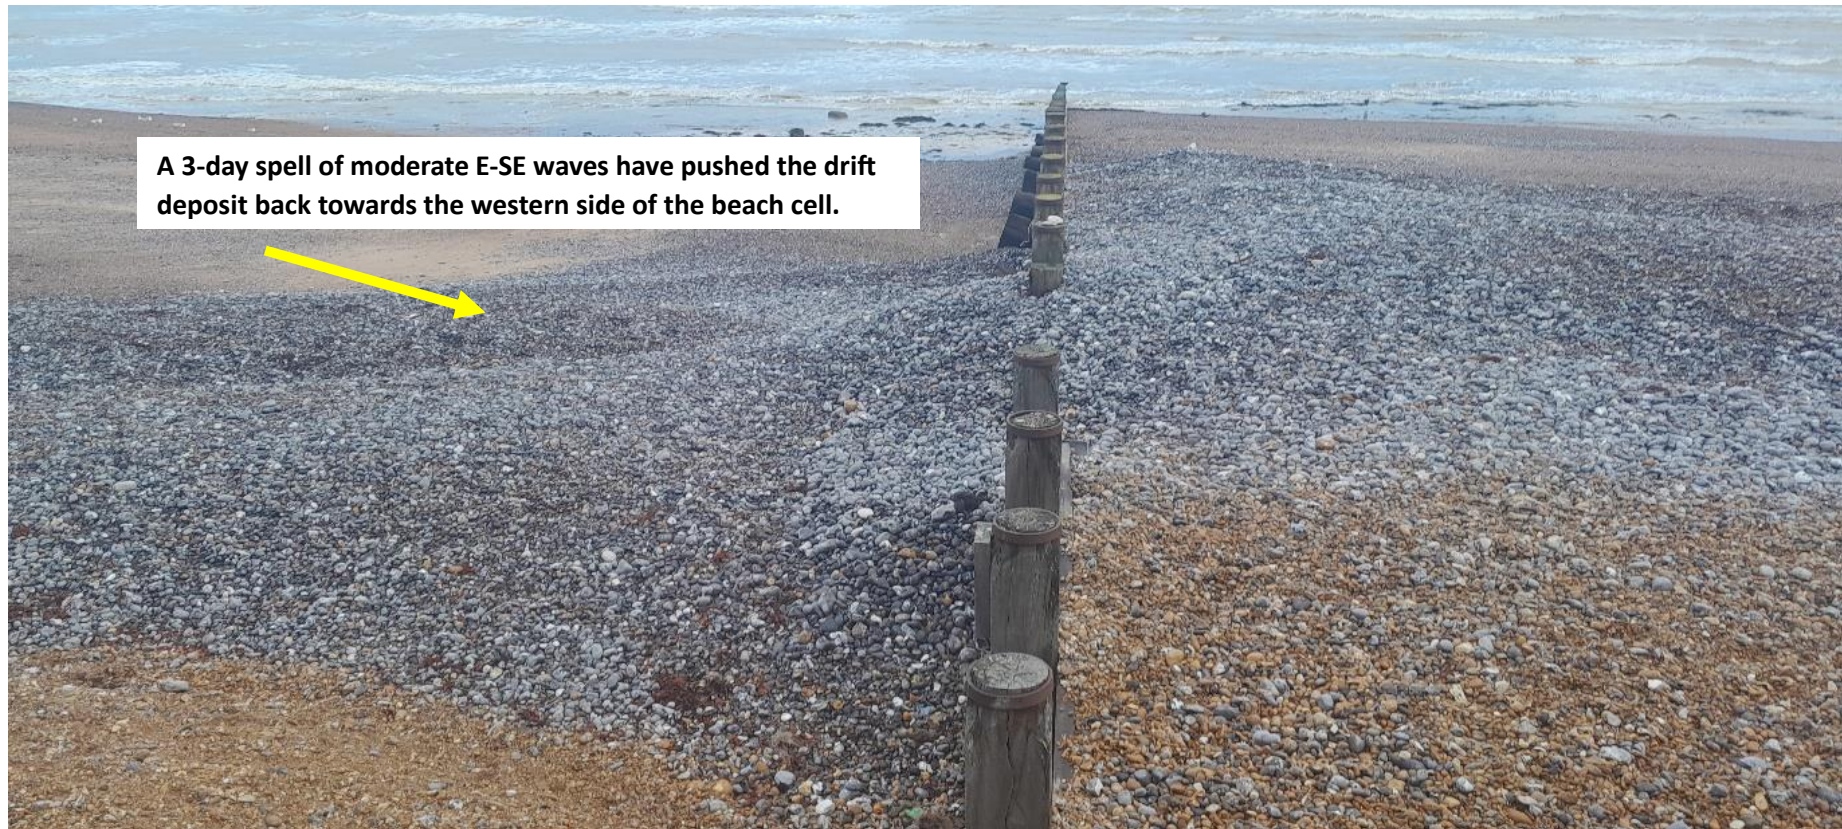
**Figure 4:** Grey cobbles overtopping the eastern groyne of a beach cell. The cobbles on the eastern side (left) have been subjected to a short period of waves impacting from a E-SE direction, this has reversed the direction of prevailing drift.

The larger cobble clasts are displaced from the HW berm slope, drawn down by gravity and back wash, deposited lower down the beach where the influence of gravity is significantly reduced. These stranded clasts are washed back up the beach by the next set of storm waves towards the NE side of the beach cell. The drift deposit will eventually overtop the groyne structure and deposit on the adjacent beach, as seen in Figure 4.

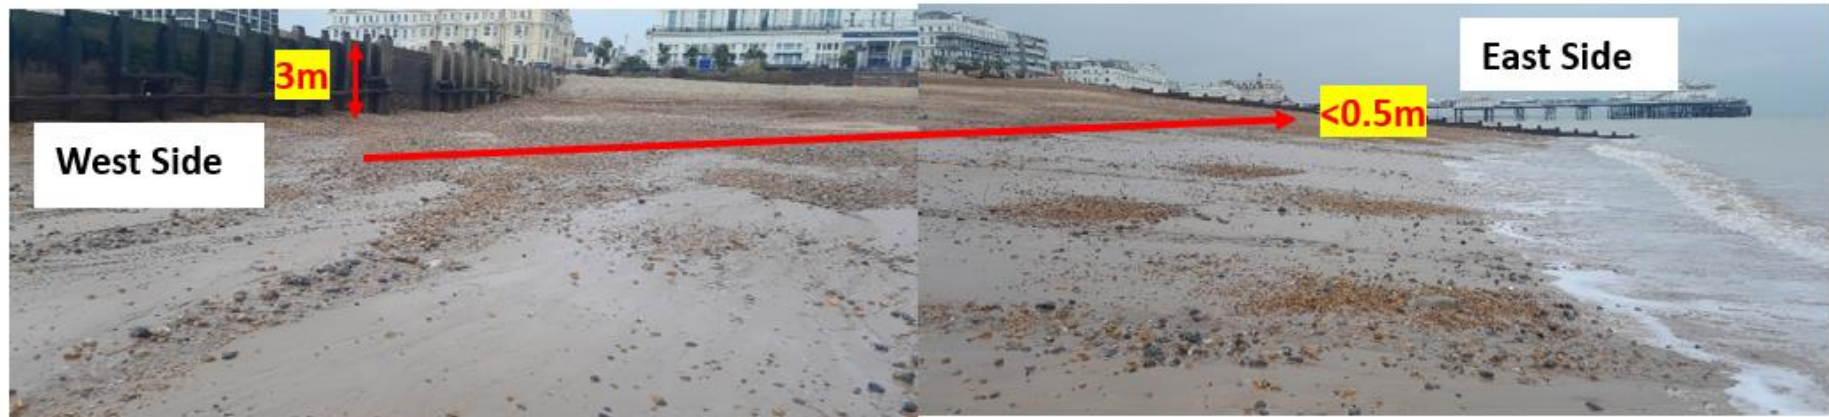
**Figure 5:** The anthropogenic sediments, a chaotic mix of sand gravel and occasional cobble, are easily drawn down the beach and then pushed up against the eastern groyne by prevailing SW waves. The sediment level along the west side of the beach cell is in excess of 3m below the top of the groyne structure. The sediments slope up towards the east side to within 0.5m of the top of the groyne. Considerable stress is applied to the groyne by the weight of ballast and the smaller shingle will overtop the groyne further down than the larger grey cobbles.

There is also a significant amount of sand within the upper beach sediments due to constant mechanical recycling. This effectively forms an unconsolidated conglomerate deposit which is easily redistributed within the mid reaches of the beach cell, resulting in a steep cross-beach profile along the entire length of the groyne barrier. See Figure 5.

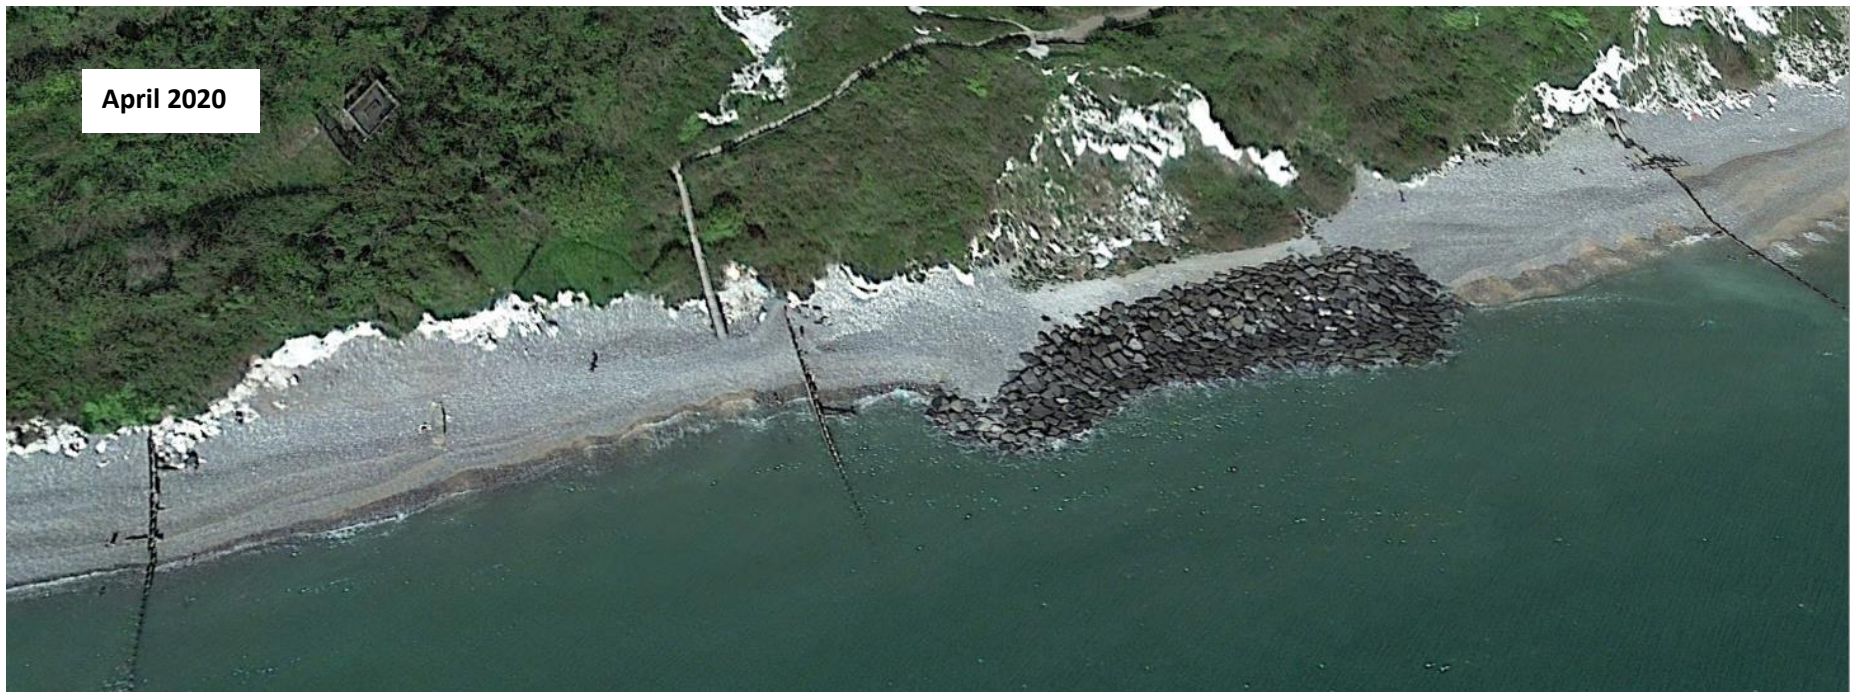
**Figure 7:** In just under 4 years a significant deposit of grey cobbles has drifted from the west to stabilise these beaches. These originated from the chalk scree deposits left on the beach following cliffs falls in 1999 and 2001.

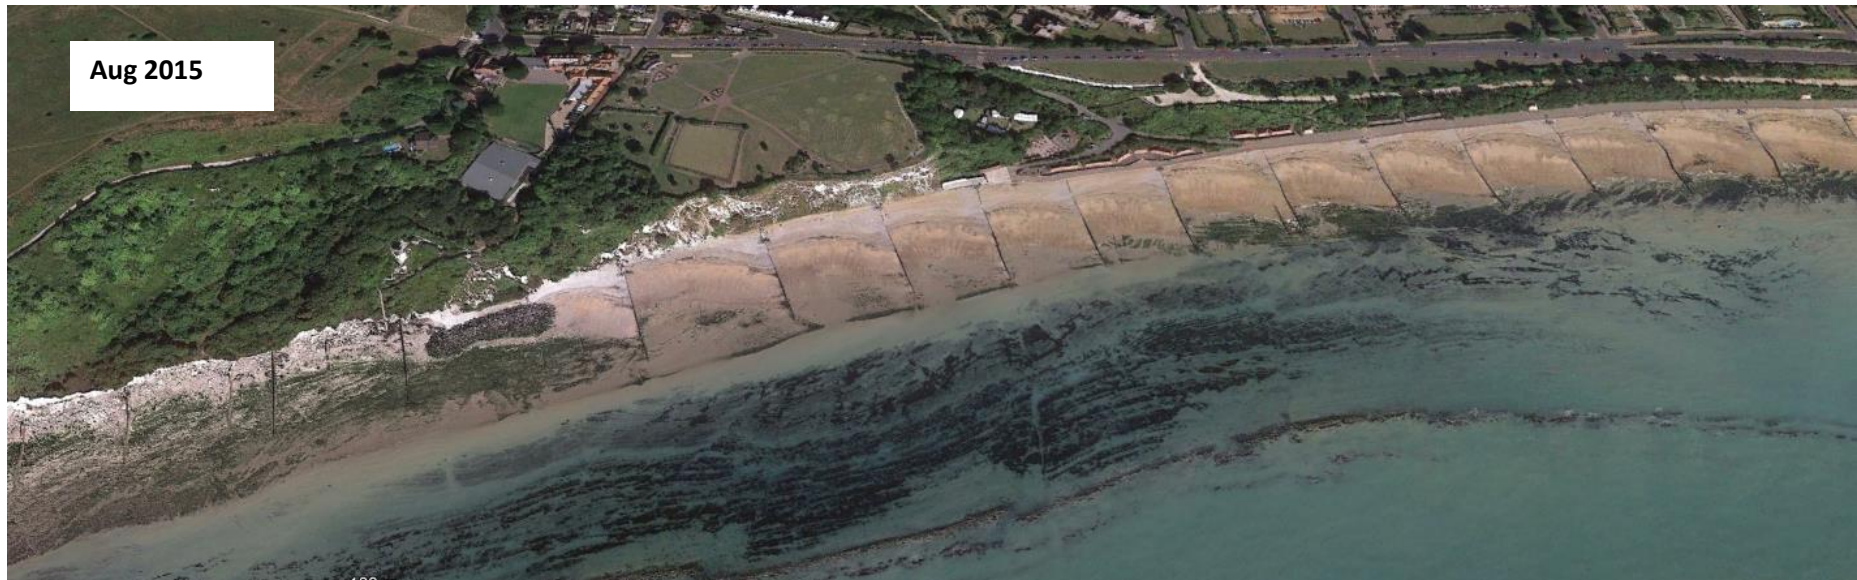
**Figure 8:** The beaches along the entire subject coastline between beachy Head and Cooden were subject to storms waves in May 2015, generated by 60 mph winds. The erosion pattern seen below the HW berms is evident along the entire 14km of subject coastline. There appears to be significant sediment loss due to draw-down and also longshore drift.

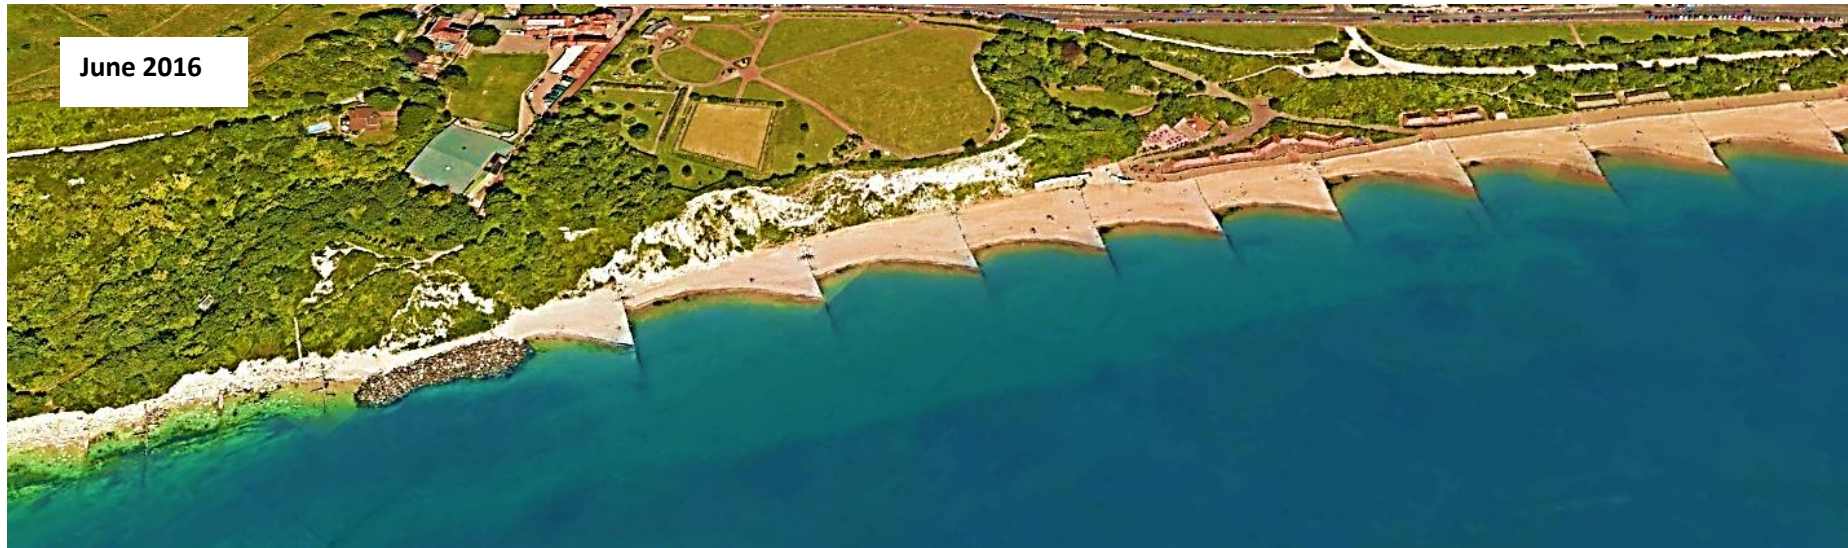
**Figure 9:** One year later the beaches appear to have been partially recharged with ballast. The beach plan-profile demonstrates the direction of longshore drift.

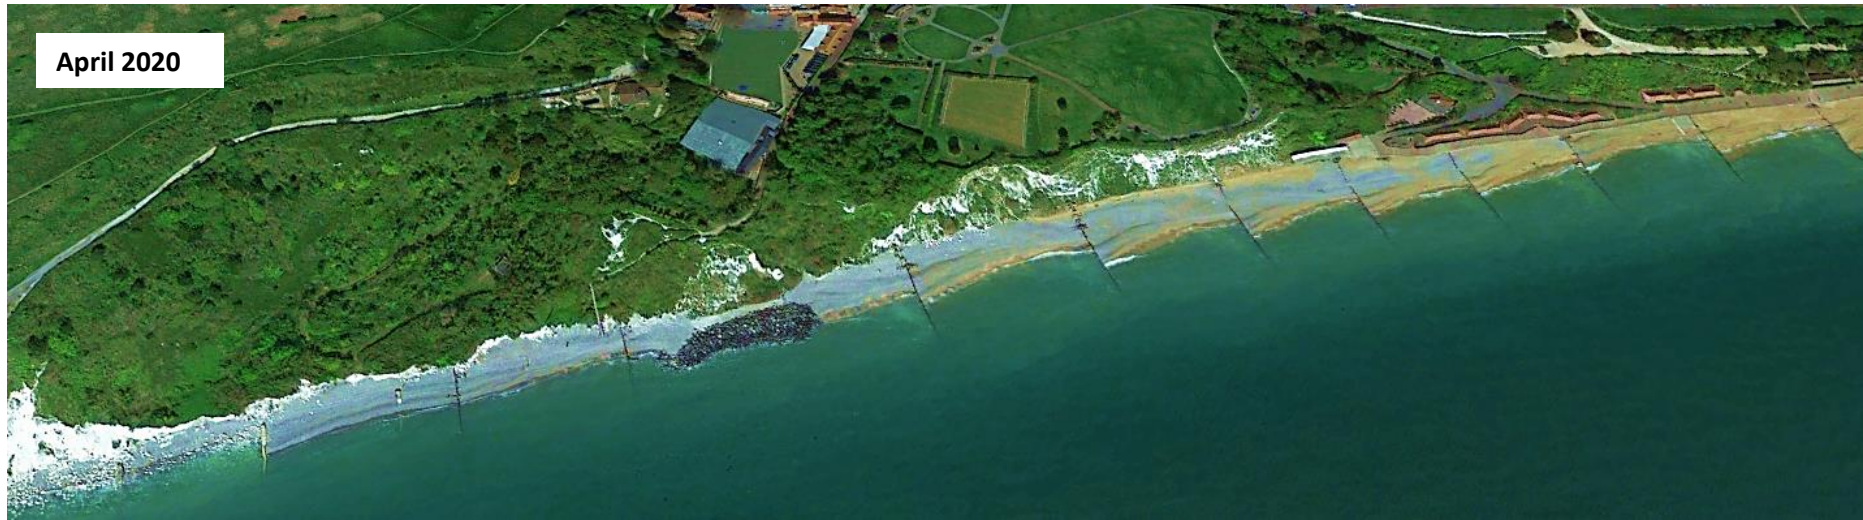
**Figure 11:** The drift deposit of grey cobbles that was eroded from cliff fall scree deposited after a cliff failure opposite Beachy Head Lighthouse in 1999 and another fall two years later at Devils Chimney. Wave action erodes the flint from the chalk and then pushes the clasts along the cliff base. The sporadic nature of these events means that the beaches deposits wax and wane in response to cliff falls. It appears to have taken over two decades for the waves and tide to erode the flint from the chalk scree and push it along the coast from Eastbourne Lighthouse to Holywell.

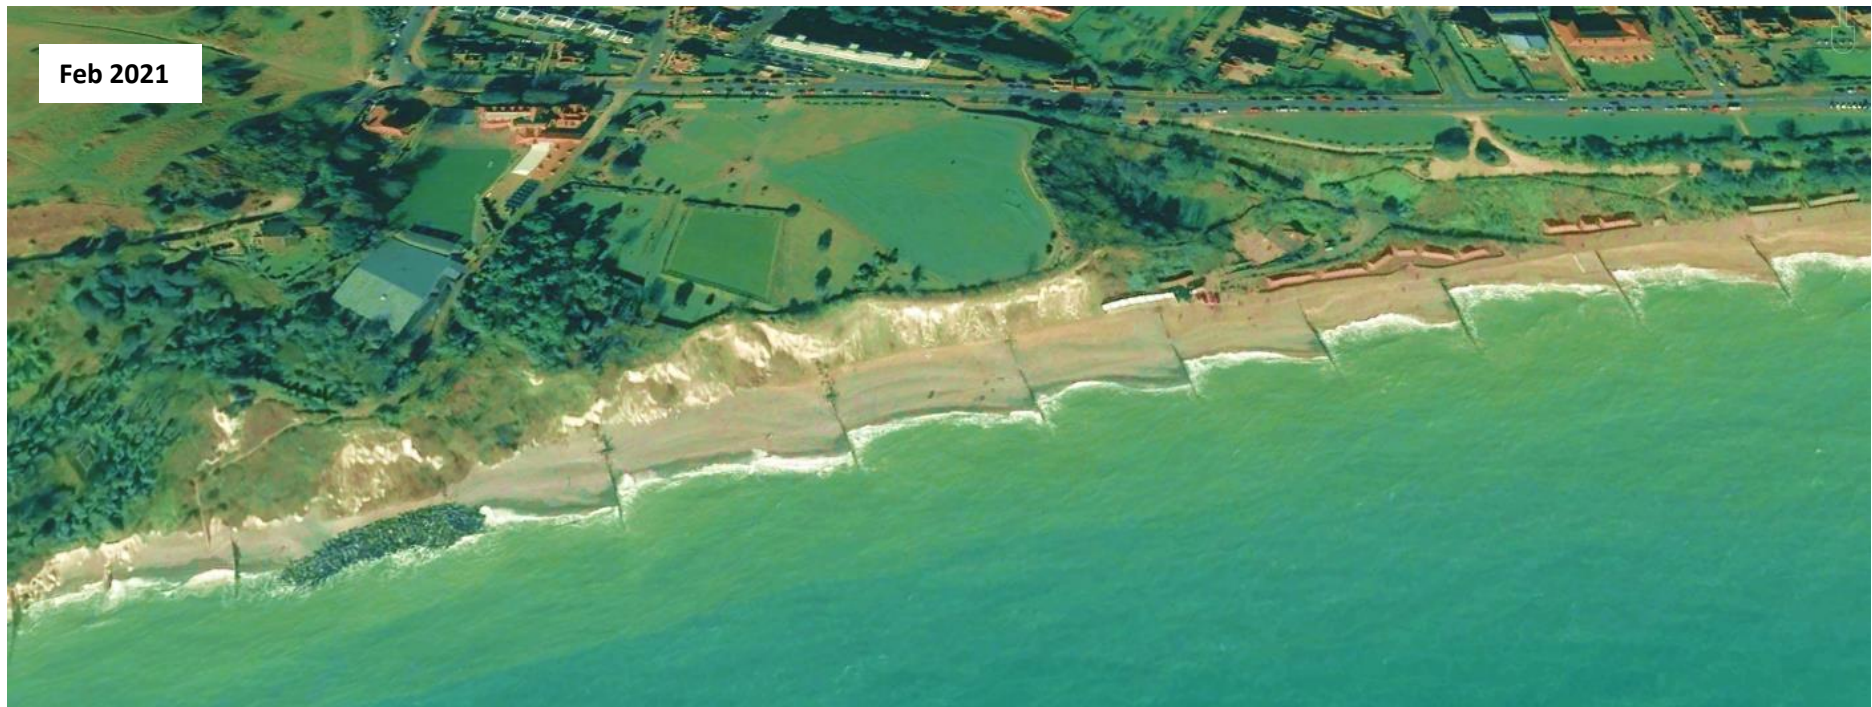
**Figure 12:** The grey cobbles and ballast have mixed within the high energy zone close to the HW berm and continue to drift eastwards and stabilise the beaches.

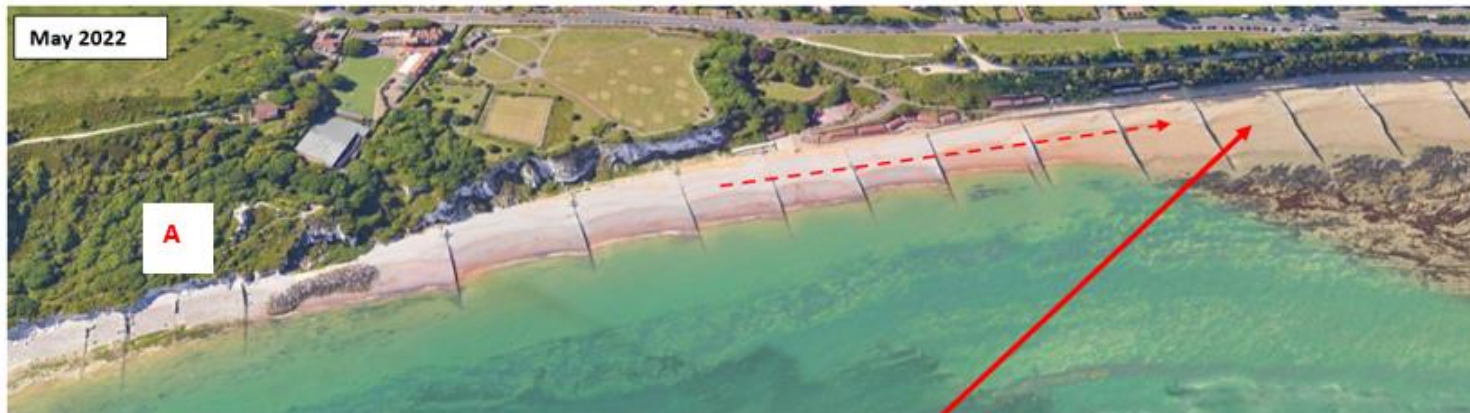
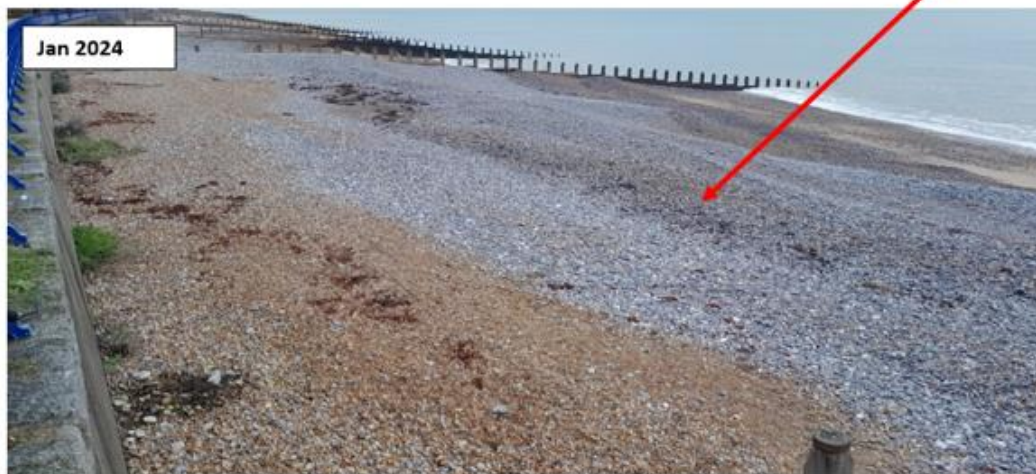
Over a period of 21 months a significant deposit of cobbles has drifted onto an unstable beach.

The minimum load required to stabilise the beach was established by October 2023. Subsequent storms were repelled and further cobbles added from beaches to the west.

The beach to the west of the rock armour is now depleted A

**Figure 13:** In under two years sufficient cobbles have drifted onto the beach and stabilised it. Only a relatively thin veneer 5m wide stretching across the entire beach is required to prevent erosion. There is actually a surfeit of cobbles on this beach with the excess above minimum load deposited below the HW berm. Cuspate features have been formed within the lower section.

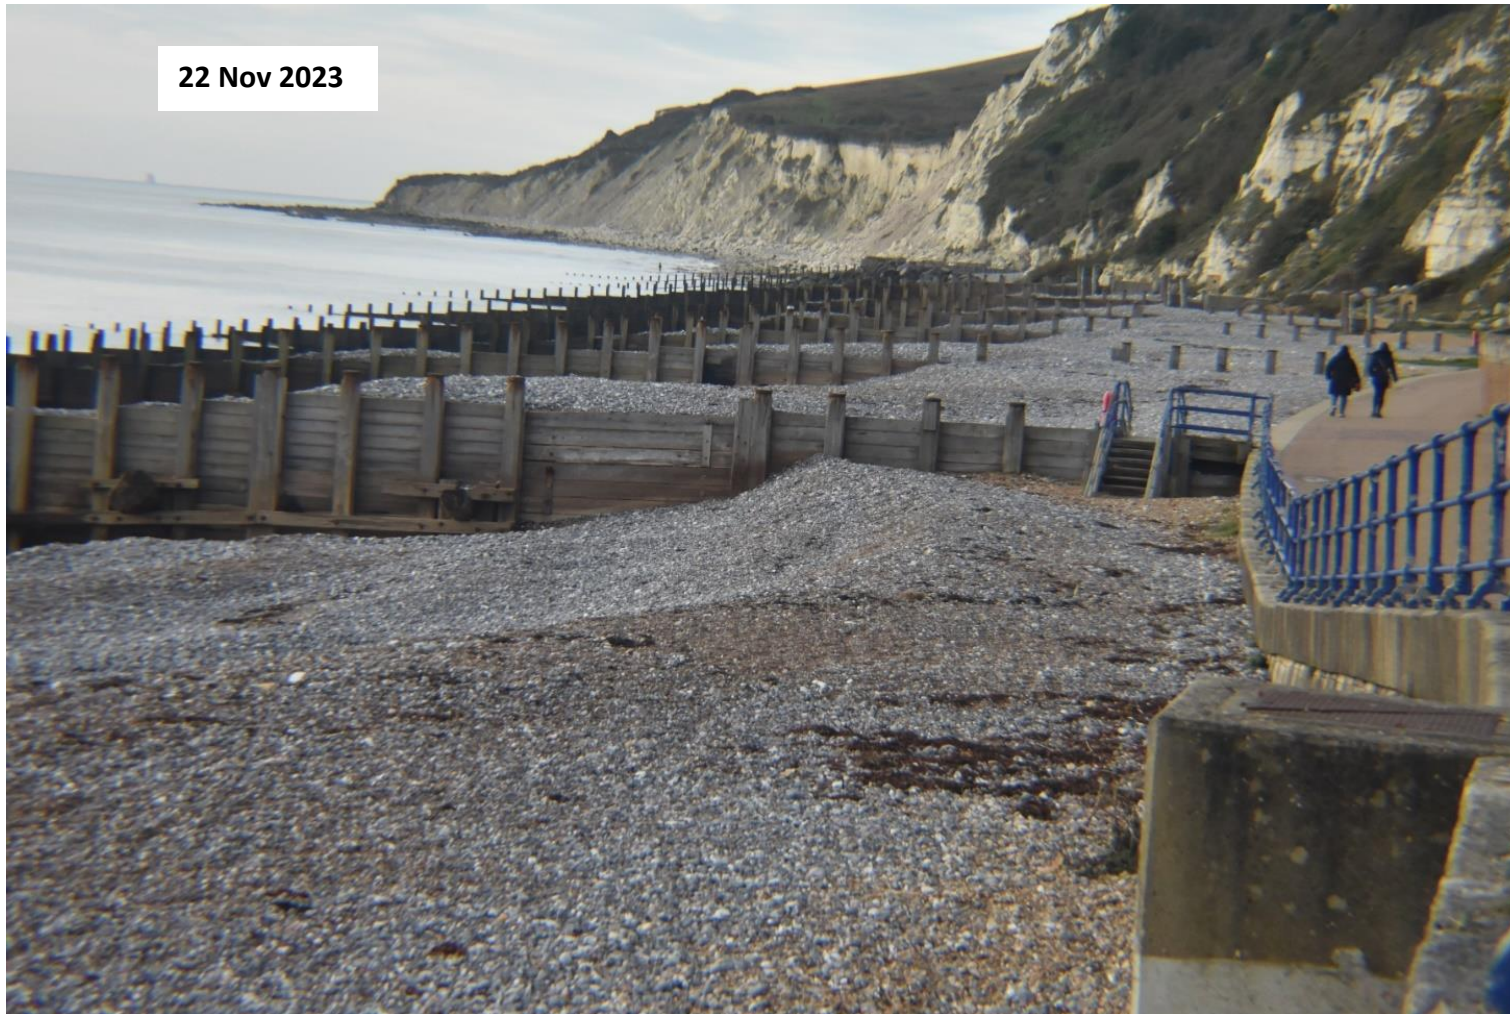
**Figure 15:** The beach adopts an undulating upper beach profile and the orange-brown ballast is displaced by grey cobbles indicating that the beach is becoming stable with the correct grade of sediment. The larger clasts eventually displace the ballast, further stabilising the beach.
