Sea[®]Scapes 2030

Beach Sediment Dynamics

- **Case Study**
- Feb 22 to July 23

Case Study B-Sediment Dynamics within the Inter-Tidal Zone

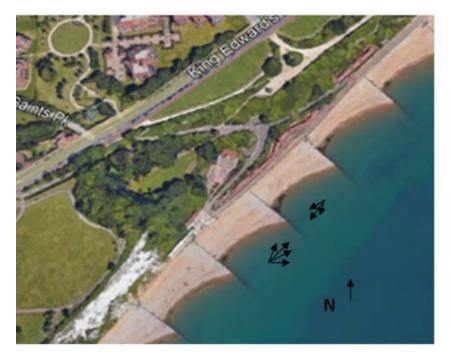
Figure 2: Beach profiles show the shingle stacking up against the northeast side of the beaches along Holywell. The vector arrows are extracted from wind roses. Image Google Earth.

The cross-shore beach satellite view demonstrates the longshore drift trend in a northeast direction along the Holywell promenade. The intervention of the wooden groynes and sea wall forces the shingle beach into the observed formations. The wave energy vectors, extracted from a wind rose data shows the predominant north east vector.

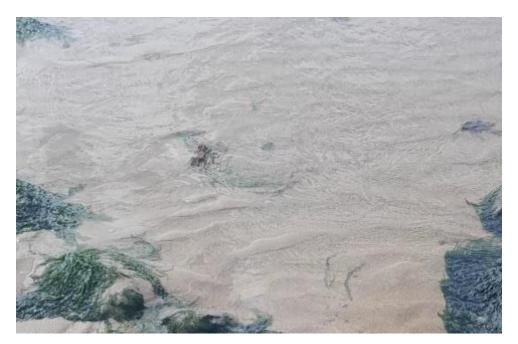
Figure 6: Sand between rocks at Holywell are formed into irregular sand waves several cm wavelength and 2-3 cm amplitude. The water is run-off from the shingle accumulated at high water. Photo G. Caira.

Bedforms also migrate, as grains of sand are forced to roll along the seabed by tidal currents and passing waves. Within the subject coast these mobile and often fleeting features vary in size from a few cm (as seen in the photo above) to tens of meters further offshore. See example in Figure 6, below.

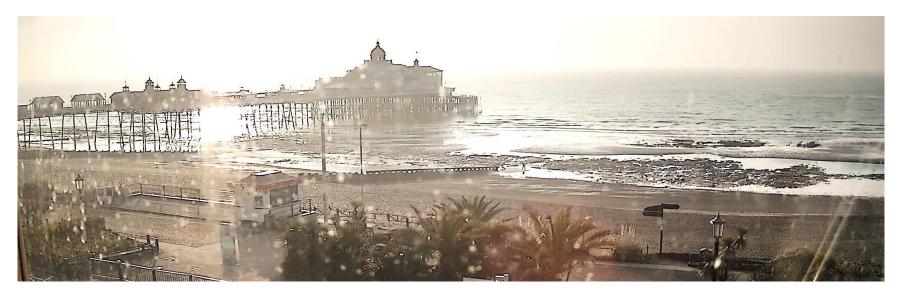
Figure 8. In the 13 months between the dates of the two photos the surficial cover of Sand has been eroded away exposing Gault. The groyne is also significantly more exposed compared to February 2022. Image from beach camera at the end of Terminus Road.

Geomorphological processes of draw down and longshore drift are responsible for the losses. However, losses are accelerated by the shingle sand mix sprayed onto the beaches over the past 20 years and compacting of the sand shingle mix into hard sloping beach by the machines reprofiling the beaches.

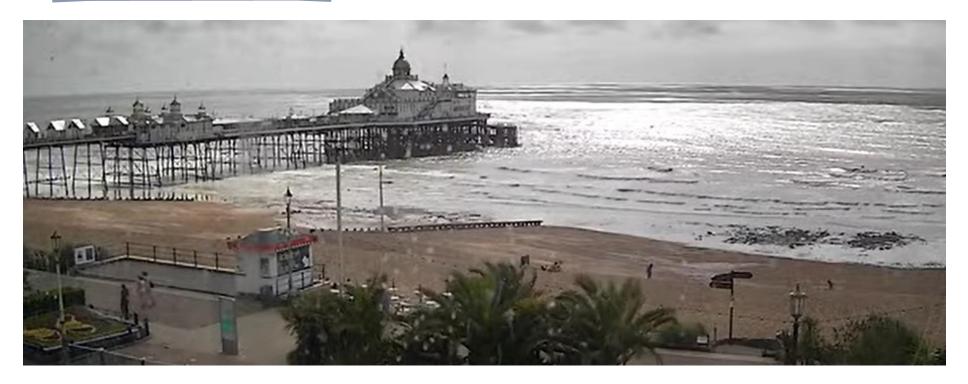
Figure 10: Between 2nd and 23rd July 2023 a significant amount of sand and shingle has drifted down and across the beach. Compare the exposure of the wooden groyne in the center of the images with that in Figure 9, above. Image from beach camera at the end of Terminus Road.

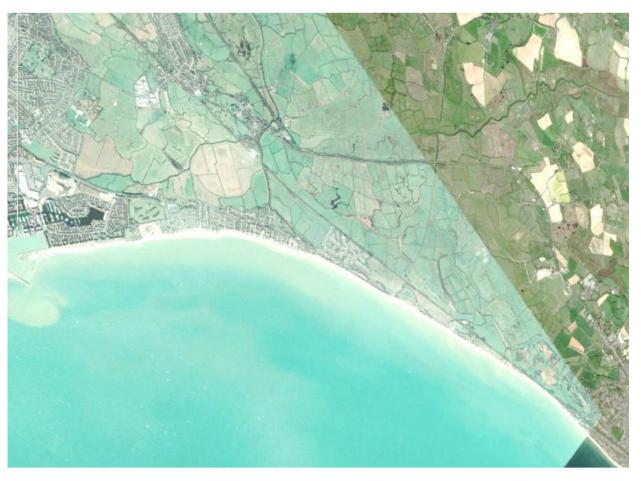
Figure 11: The fine sediments appears to be within the water column, the light patches close to the coast between the harbour and Cooden. Image Google Earth.
